INOJOSA, Leonardo da Silveira Pirillo et al. Numerical safety and performance analysis of a multipurpose building's structure : case study. **Concilium**, [S. l.], v. 23, n. 19, p. 87–99, 2023. DOI: <https://doi.org/10.53660/CLM-2070-23P19>. Disponível em: <https://clium.org/index.php/edicoes/article/view/2070>. Acesso em: 31 jan. 2024.

## Numerical Safety and Performance Analysis of a Multipurpose Building's Structure – Case Study

### Análise Numérica de Segurança e Desempenho da Estrutura de Edifício Multiuso – Estudo de Caso

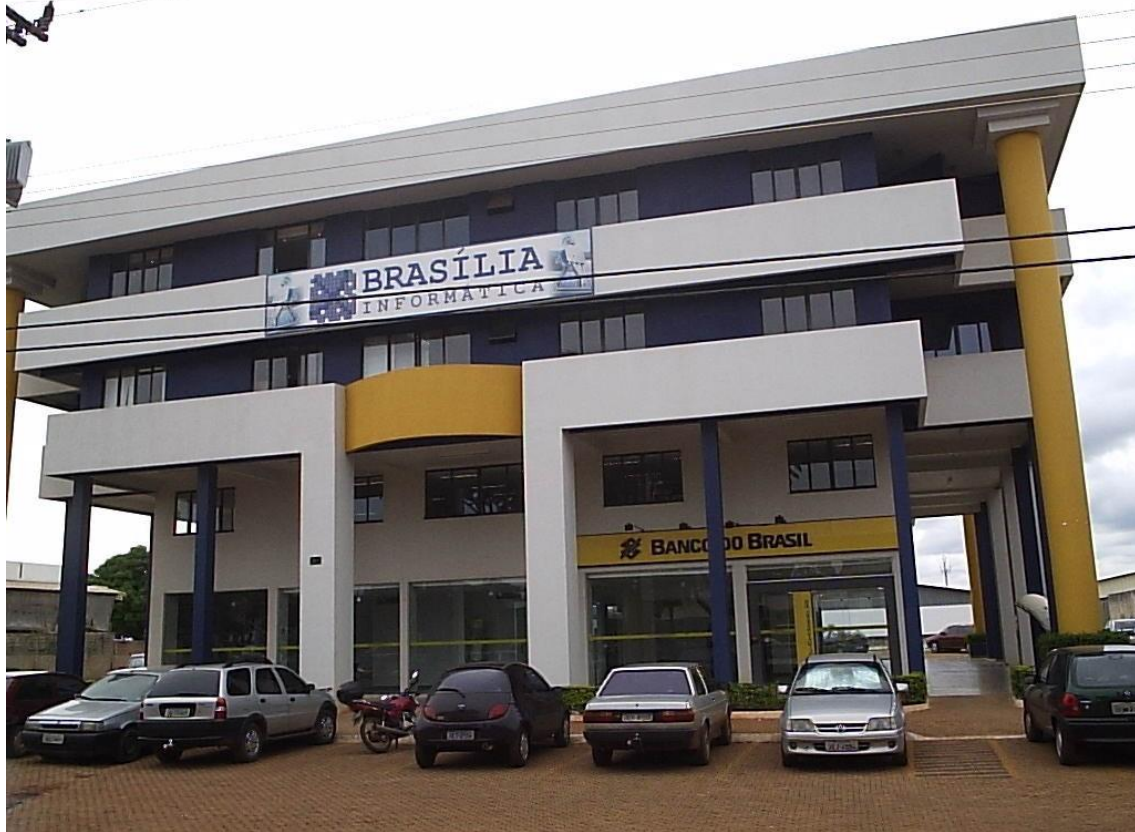
**Figure 1** – Main façade of the studied building, during the first inspection in 2005.

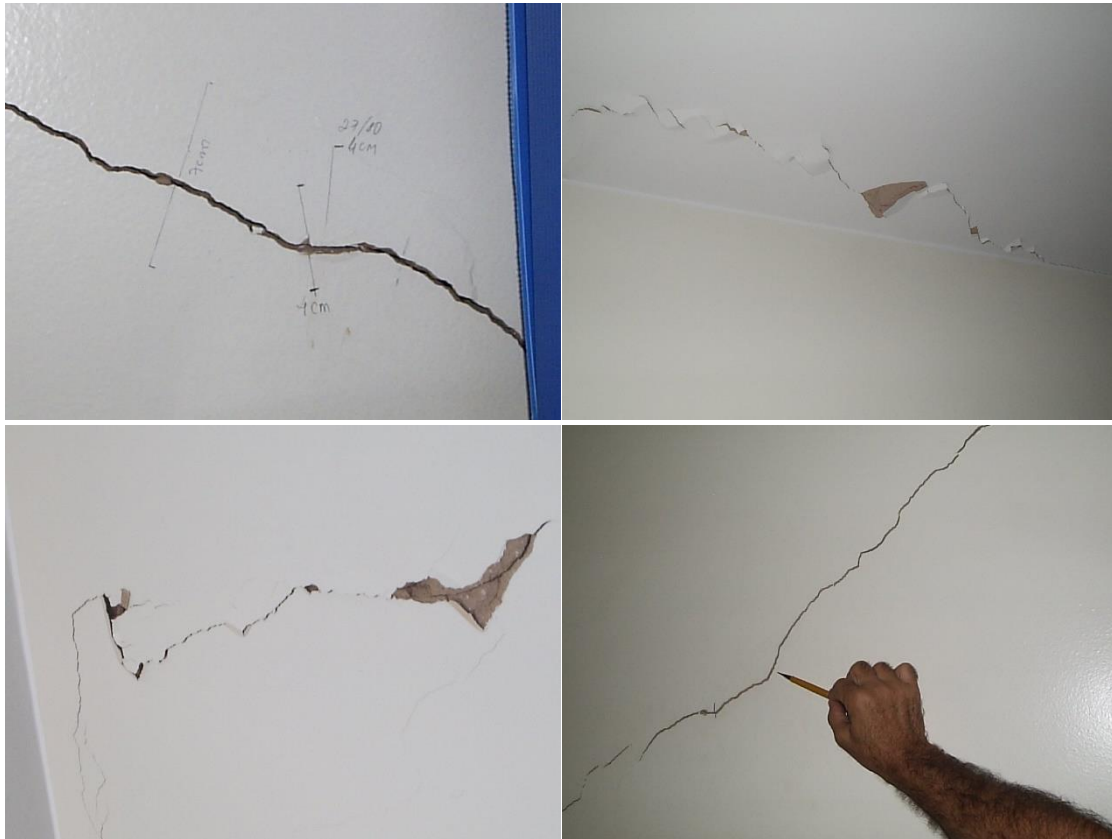
Despite encountering issues such as cracks and fissures on walls and slabs (Figure 2), the examination did not reveal any instability problems. The analysis of elastic instability indicated that the building has a stable structure, although deflections were observed above the standard limit, which contributed to the appearance of cracks in the masonry.

As per the survey, it was observed that the building and its surrounding areas were not sufficiently equipped to contain rainwater. As a result, the stormwater gallery had to be cleaned and waterproofed, which was identified as one of the primary reasons for the pathologies detected.

**Figure 2** – Cracks and fissures observed in visual inspection in November 2005.

Therefore, it has been recommended that the building undergo preventive maintenance measures in order to guarantee its safety. This involved repairing the masonry and slabs, as well as addressing and treating all cracks. It is important to stress that preventative maintenance and restoration are essential not just for the safety of those utilizing the building, but also for the building's long-term resilience.

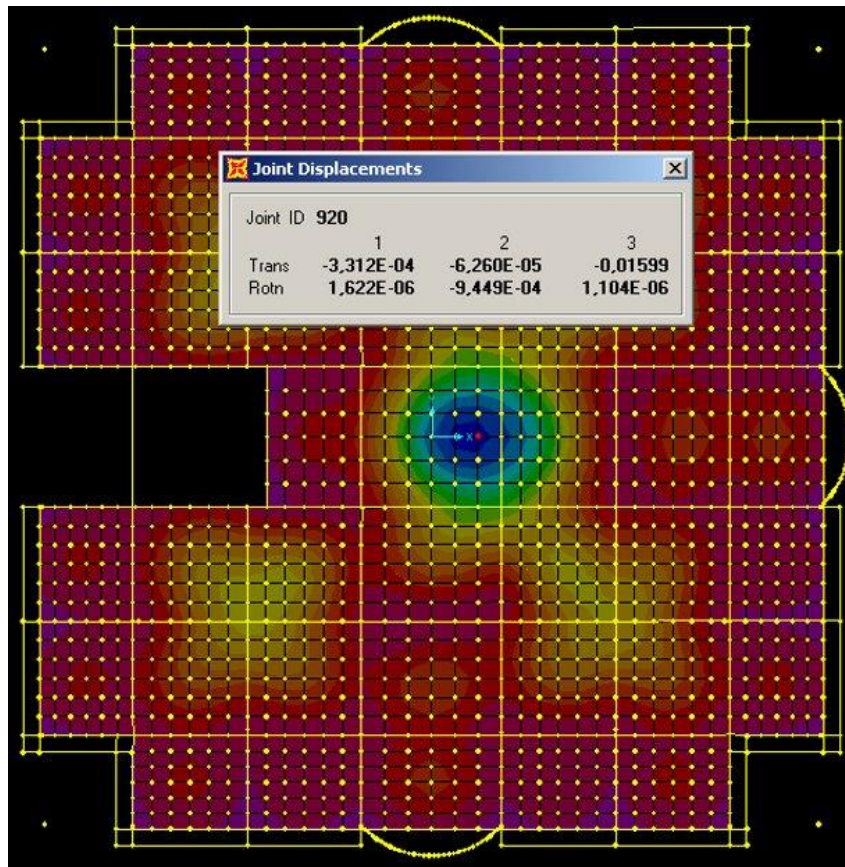
Figures 9 and 10 show the maximum vertical displacements of the bar elements at the overstore level. As shown, the displacement of certain beams has exceeded standard limits, which led to the development of cracks and fissures in the masonry.

**Figure 9** – Plan of maximum vertical displacements (Z) for Overstore slab.

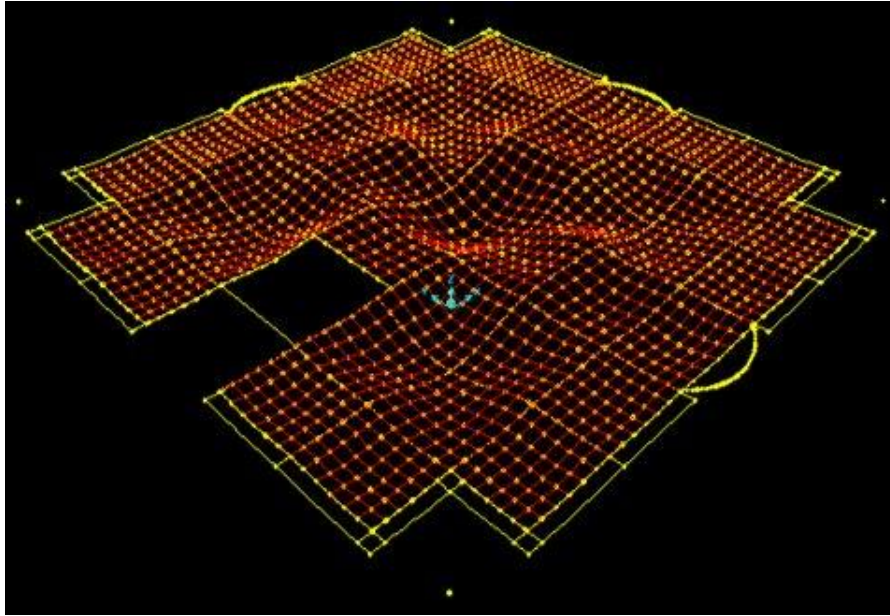
**Figure 10** – Perspective graph of the maximum displacements in the vertical direction – Z (Overstore).

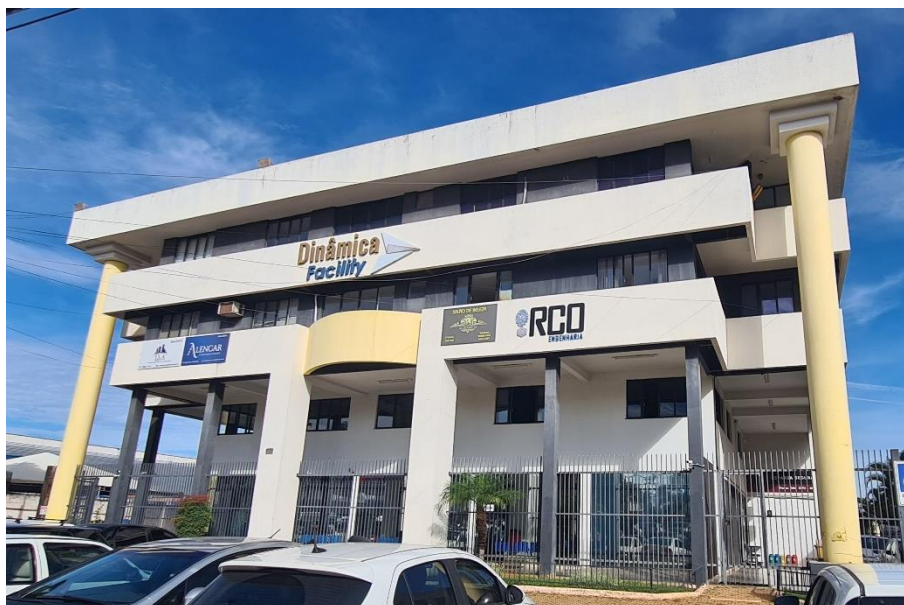
In April of 2023, the building underwent another inspection, a full 17 years after its previous inspections and interventions. The results were favorable. During this visit, it was discovered that despite changes in usage and occupancy, the building had undergone preventive maintenance as recommended. Structural elements and treatments were kept intact, and measures were taken to prevent the formation of new pathologies. Figure 11 shows the condition of the building's structural elements.

**Figure 11** – Main façade of the studied building. Author's Photo in April 2023

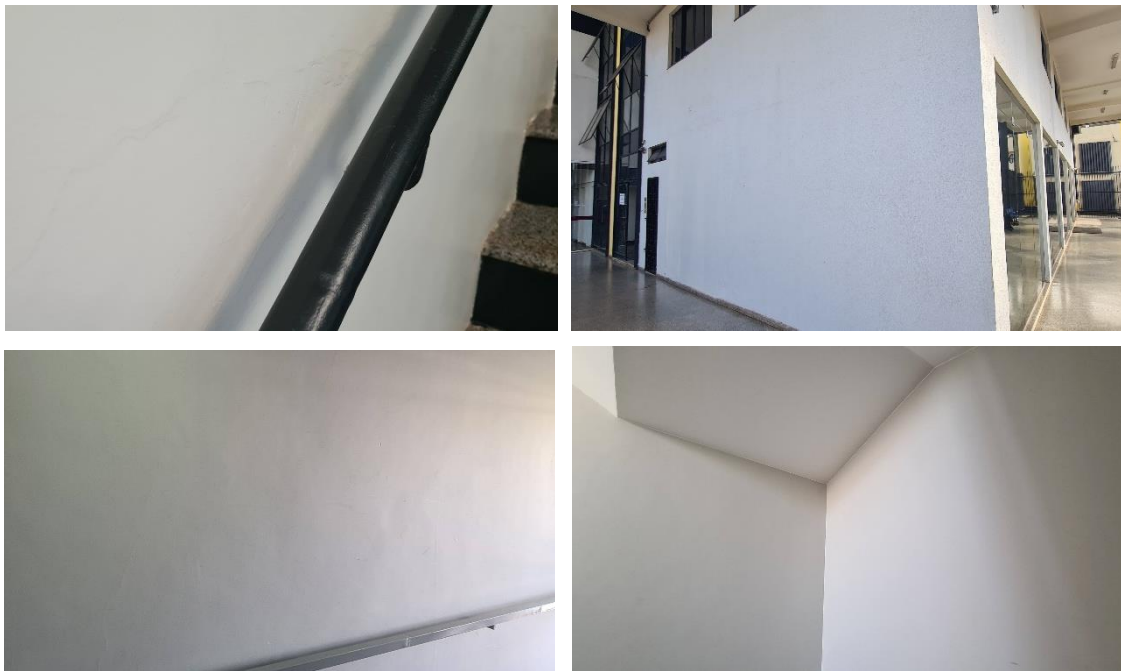
The treatments performed in the building adhere to the principle of designing them based on the identified causes of problems found in the surveys. In this case, the improper containment of stormwater in the building and its surroundings was the cause. This principle allows the interventions to be successful in suppressing or minimizing as much as possible the elements that cause the pathologies (THOMAZ 2006). As preventive measures for new occurrences are adopted, we can see in Figure 12 the efficiency of repairs, 17 years later.

**Figure 12** – Actual conditions of the treatments for cracks and fissures, observed in visual inspection in April 2023.
