INSPECTION METHOD IN BAMBOO ROOFS: ASSESSMENT OF THE CONSERVATION CONDITIONS BY USING A DRONE AND SENSORY ANALYSIS

Lara Monalisa Alves dos Santos, University of Brasilia, BR, laramonalisa.arquitetura@gmail.com
Vanda Alice Garcia Zanoni, University of Brasilia, BR, email, vandazanoni@unb.br
Jaime Gonçalves de Almeida, University of Brasilia, BR, jagal@unb.br

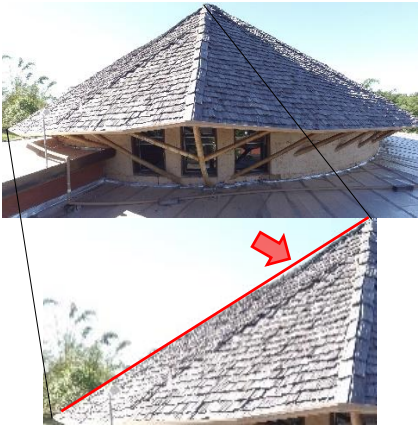
The accentuated deformation (T-1) is associated with the loss of functionality of the support structure, in this case, the rafter (Figure 3 in Table 5). Monitoring is necessary to carry out corrective actions, such as the removal of compromised elements, correctly replacing their fixations for greater stability.

<p data-bbox="231 1014 718 1077">Figure 03 - Excessive deformation of the roof</p>

The damage for the two manifestations found in the inspection is level 2, due to the anomalies, maintenance and monitoring should occur every 6 months with eventual repairing.

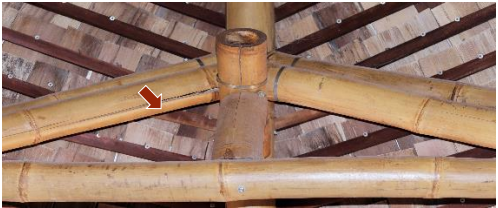
In Figure 6, it was possible to identify the presence of the short fissure (E-2) caused by temperature variations and its exposure to the weather, located on the external and internal sides of the buildings. For structural parts present inside, preventive maintenance must be carried out every 2 years.

<p>Figure 06 – Short crack in the structure of the Multipurpose Room building</p>	<p>E-2 Short crack</p>	<p>4 – Actions requiring corrective maintenance</p>

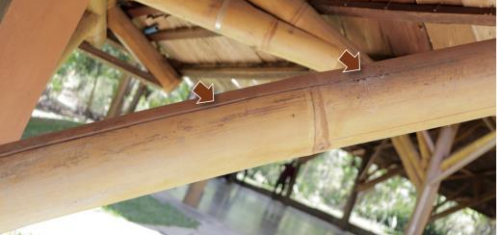
Biological degradation was identified through the presence of xylophagous insects (E-3) in the structures of all buildings because of the lack of preventive maintenance, see Figure 7. The insects feed on different parts of the stem (woody tissue), while the advanced fungi stage affects mechanical strength. It is important to point out that action must be taken on the causes of occurrence of anomalies, as the number of affected parts may increase.

<p>Figure 07 - Short fissure and the presence of xylophagous insects detected in the compostable Wc building</p>	<p>E-2 Short crack E-3 Xylophagous insects</p>	<p>3 – Actions requiring corrective maintenance</p>

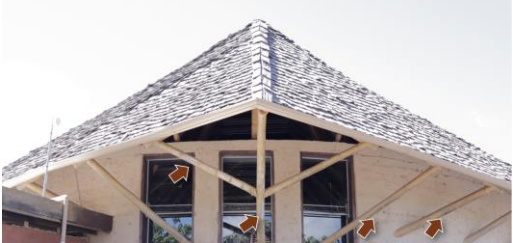
Photodegradation (E-4) is an anomaly and was identified only on the outside of the structure, Figure 8 in Table 7. This anomaly is caused by the building's implantation and its solar orientation. The pieces that show photodegradation are located on the north, south, and east facades. As a result of the direct exposure of the structural elements to climatic conditions (rain and sun), there is a change in the color of the bamboo, creating an environment conducive to attack by biotic agents and humidity, accelerating its deterioration. The recommendations are cleaning, sanding, and varnishing to restore the uniformity of the color and the protection of the material.

<p>Figure 08 – Structure with the presence of photodegradation on the north facade of the Main Hall building</p>	<p>E-4 Photodegradation</p>	<p>3 – Actions requiring corrective maintenance</p>

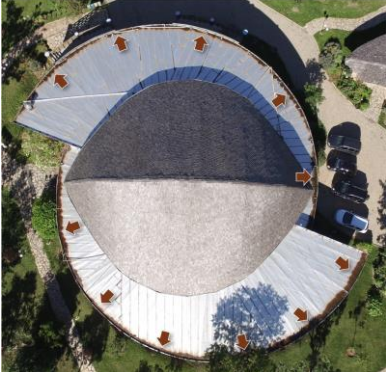
Surface dirt and debris accumulation (M-2) in Figure 10 are evident in the waterproofing membranes of the Main Hall building - they are interconnected and associated with poor maintenance (Table 8). However, the low slope of the roof and the drainage system, the incorrect execution of the element, and the environmental actions (strong winds, biological action, and atmospheric pollution) can cause the appearance of this type of anomalies. The entire blanket must be cleaned with a low-pressure water jet or manual brushing.

<p>Figure 10 – Waterproofing membranes</p>	<p>M-2 Surface dirt and debris build-up</p>	<p>4 – Actions requiring corrective maintenance</p>

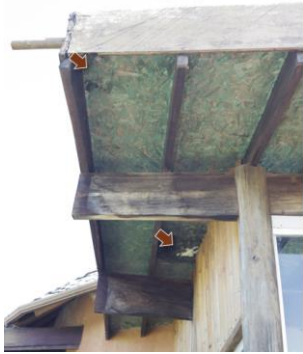
In the green roof system of the multipurpose hall (Figures 13 and 14) the points with the highest amounts of mold are caused by the drained water in the region of the gutters. In this system, anomalies related to lack of maintenance and errors in project execution were found.

<p data-bbox="233 1272 839 1339">Figure 13 - Infiltration caused by the accumulation of water present in the Multipurpose Hall building</p>	<p data-bbox="903 1088 1062 1162">F-1 Moisture patches</p>	<p data-bbox="1123 1072 1380 1178">4 – Actions requiring corrective maintenance</p>
