INOJOSA, Leonardo da Silveira Pirillo et al. Concepção arquitetura-estrutura no projeto e análise de desempenho do edifício CCBB em Brasília. **Concilium**, [S. l.], v. 23, n. 19, p. 332–346, 2023. DOI: 10.53660/CLM-2114-23P49. Disponível em: <https://clium.org/index.php/edicoes/article/view/2114/1386>. Acesso em: 24 jan. 2024.

## Architecture-Structure Conception in the Design and Performance Analysis of the CCBB Building in Brasilia

### Concepção Arquitetura-Estrutura no Projeto e Análise de Desempenho do Edifício CCBB em Brasília

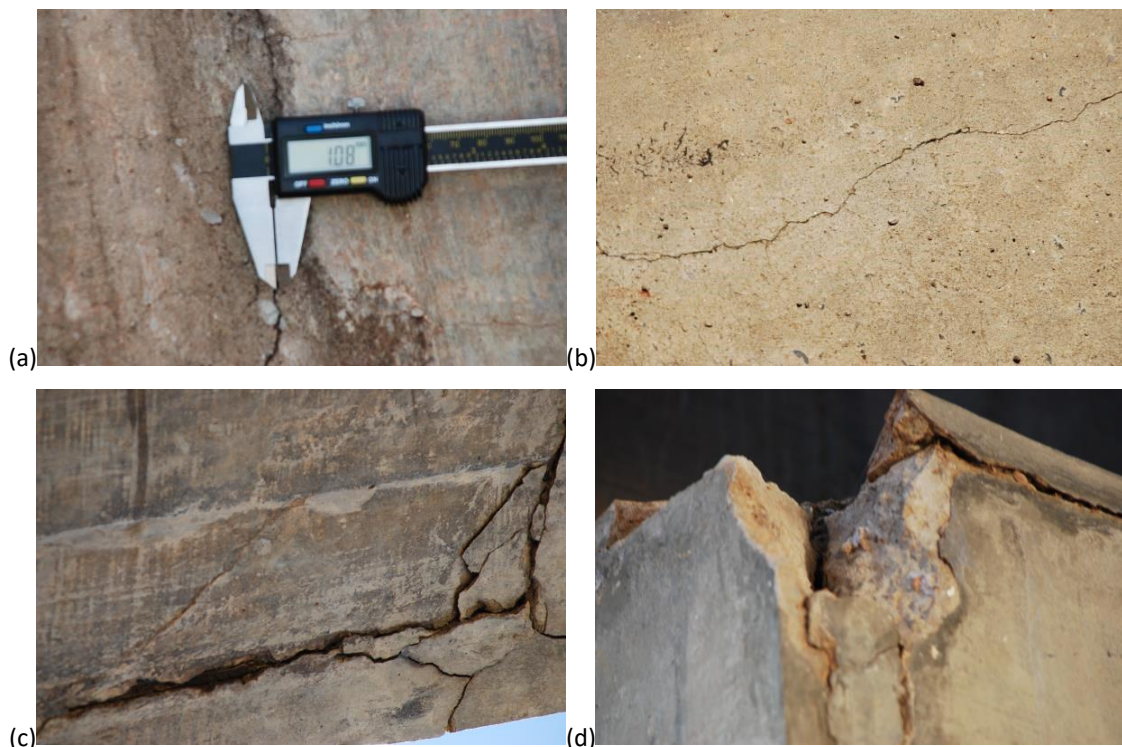
The columns mostly had characteristic cracks of the order of 1 mm in the center line of the section. This type of crack must be repaired to avoid possible contamination of the reinforcement and trigger a corrosive process that may compromise the strength function of this structural part. Other pathological manifestations, such as leaching in the concrete, corrosion, crushing of the concrete section, and corrosion in the connecting plate of the bracings were identified in almost the entire extension of the building.

Figure 9 shows two examples of cracks located in columns (a) and (b), which presented different advances and openings. We also see examples of concrete plate detachments that occur due to the absence of reinforcement or even low tensile strength of the concrete, causing it to begin to disaggregate and cause detachment in relation to the main structure. These manifestations were identified in several elements, such as (c) and (d).

**Figure 9** – Examples of cracks and detachments, identified in columns (a) P1B and (b) P4A, (c) P6A and (d) P6B.

For treating cracks, it was recommended to apply epoxy-based grout. Cracks with openings smaller than 1.0mm require the application of grout every 5cm, while those with openings between 1.0 and 10.0mm need it every 30cm (HELENE, 2001).

In cases of concrete plate detachment, the recommended solution was to use 35MPa cement-based grout with extra reinforcement. Before applying the grout, the damaged concrete should be removed using appropriate equipment. A steel cage with vertical reinforcement was designed, forming a concrete jacket, using steel bars with dimensions that match the depth and length of the repair. The maximum coverage should be 4.0cm, and the minimum should be 2.5cm. Once the reinforcement is in place, the surface can be recomposed using concrete that matches the existing material in the structure. Figure 13 provides an illustration of the steel cage design.

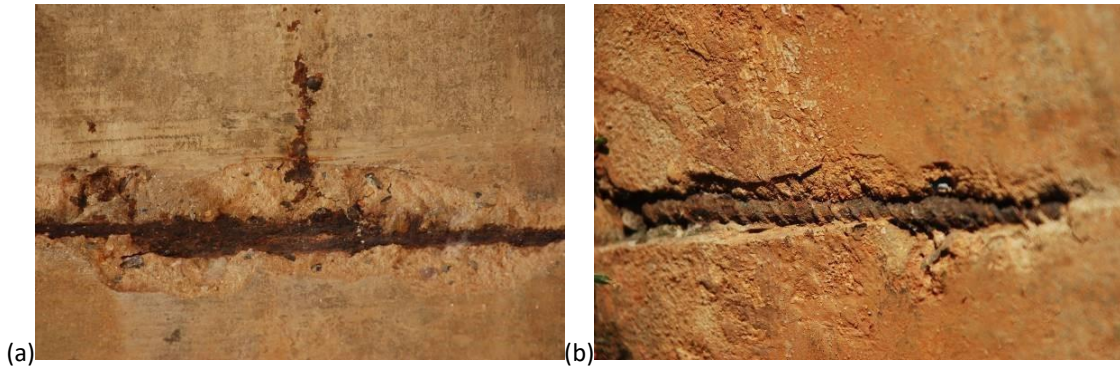
Another recurrent pathological manifestation in the building was the corrosion of armor, which usually occurs due to inadequate coverage of the reinforcement for sections of exposed

concrete or concrete with high porosity or even from poor execution of the structural piece (INOJOSA, 2022). Figure 10 shows examples of this pathology.

**Figure 10** – Examples of corrosion in the reinforcements – (a) pillar P1A and (b) external box 1. Author's photos

To address reinforcement corrosion, it is advised to remove the concrete around the bars, leaving at least 2.5 cm clearance. The armor should be cleaned, and any corrosion products should be removed with sandblasting or iron sandpaper and steel brushes. Debris should be cleared with compressed air, and the surface should be carefully hydro jetted. Applying a zinc-rich primer on the armor is recommended, followed by 30 minutes of drying time. Next, apply the epoxy adhesive on the concrete surface to create a barrier against contaminated concrete and to form an adhesion bridge. Finally, apply the mortar densifying well, ensuring that the maximum thicknesses for each material are adhered to.

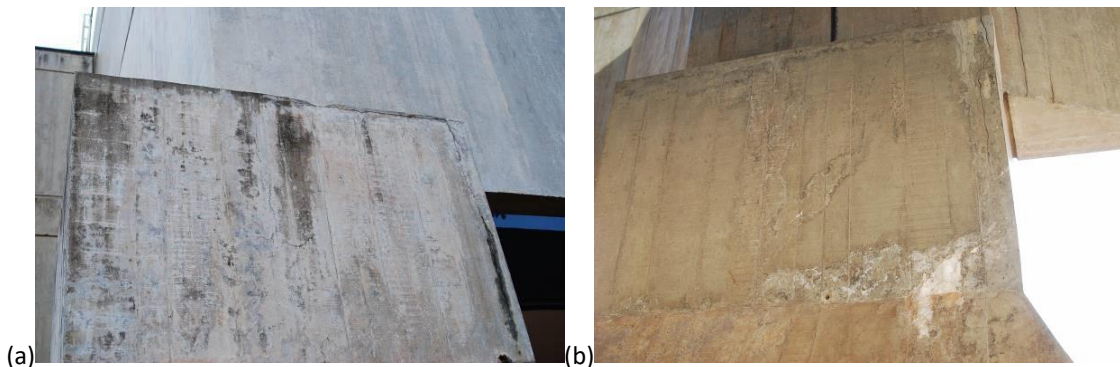
Superficial damage to the concrete structure of the building was also recurrent, these manifestations may occur due to inadequate dosage, exaggerated dimensions of the large aggregate, improper casting and densification, or even excessive rate of armor. Figure 11 shows examples of these superficial pathological manifestations, such as patches (a) or carbonation of the concrete (b).

**Figure 11** – Superficial spots found in the building – (a) P1B and (b).

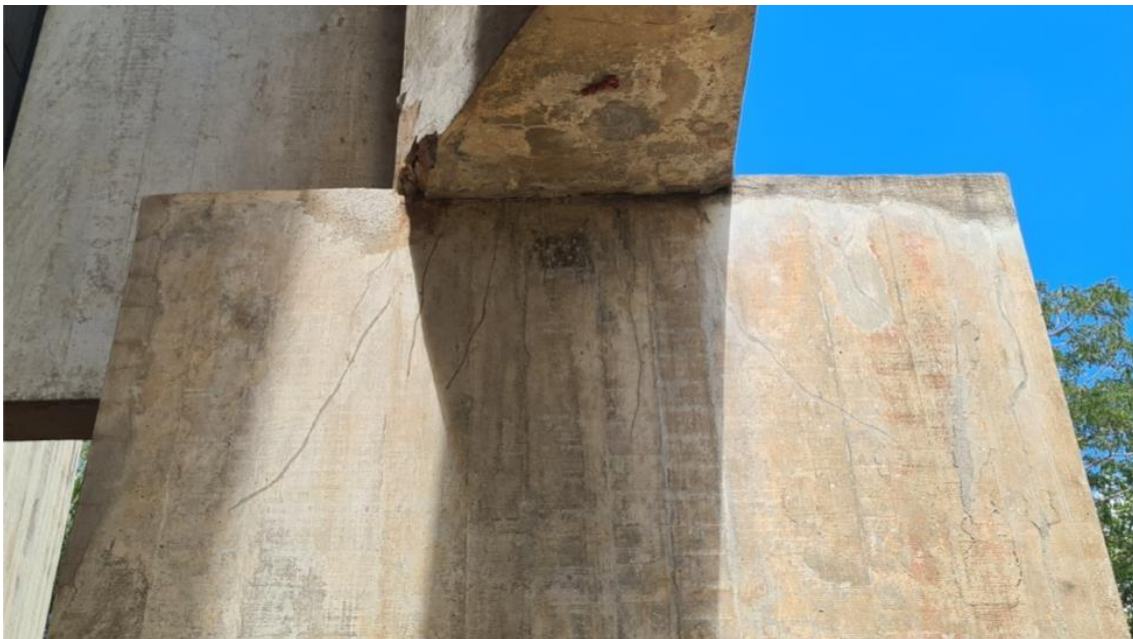
The current state of repair to the P1A column is depicted in Figure 12, which was captured during an April 2023 visit.

**Figure 12** – Treatment of cracks performed in the P1A pillar, after 15 years of execution.  
Author's photo

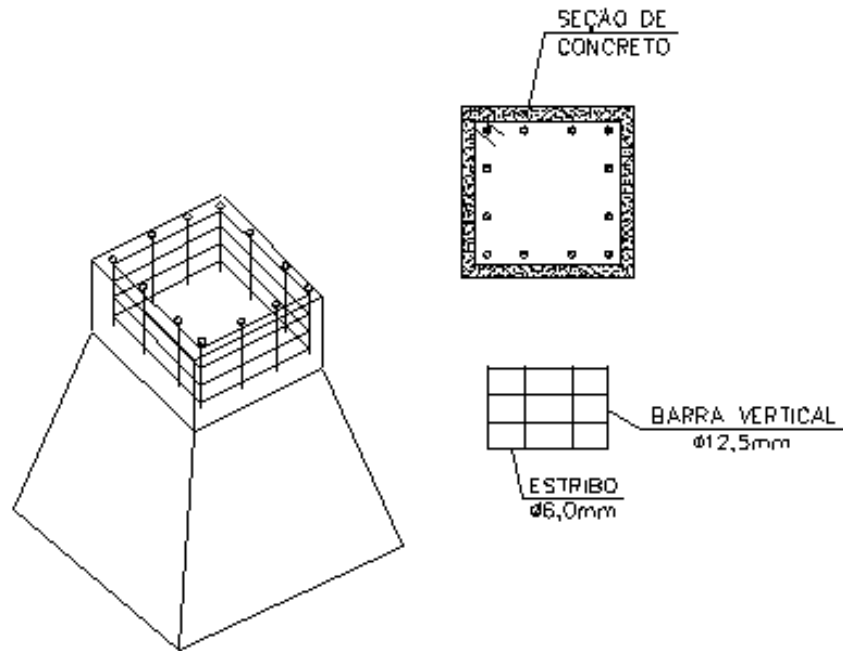
**Figure 13** – Pillar design with concrete recomposition due to plate detachment.

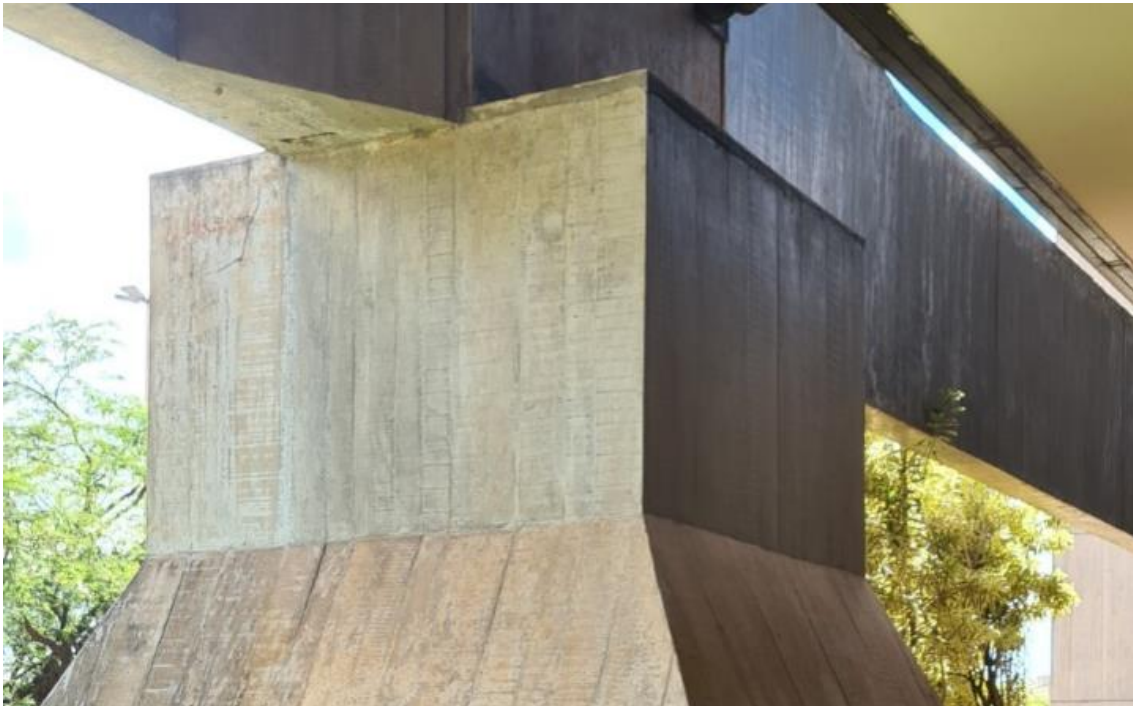
Figure 14 displays the P4A column, which has been reinforced with a concrete jacket and remains in good condition 15 years later.

**Figure 14** – Recovery and reinforcement carried out in the P4A pillar, after 15 years of execution.
