Empirical Study of the Relationship of Architectural Form Details to the State of Conservation of Modern Heritage Through Damage Maps

Abstract: The Sustainable Development Center of the University of Brasília is one of the modernist buildings that make up the Darcy Ribeiro campus. The architectural project contains several recommendations for the execution of a flat roof waterproofing system, as well as details for rainwater runoff and drainage, which reveals the architect’s concern with watertightness. This research seeks to identify the relationship between the pathological manifestations recognized on the roof and the details of the semicircular shape of the building, assessing the state of conservation using damage maps as an auxiliary analysis tool. This study is based on a field survey using aerophotogrammetry with a drone, the application of vector drawing software for graphic representation and discussion of the possible causes, and the agents and mechanisms of degradation at work. The results show the importance of mechanical protection for the good performance of the waterproofing system, as well as the need for correct sizing of expansion joints to absorb and relieve th

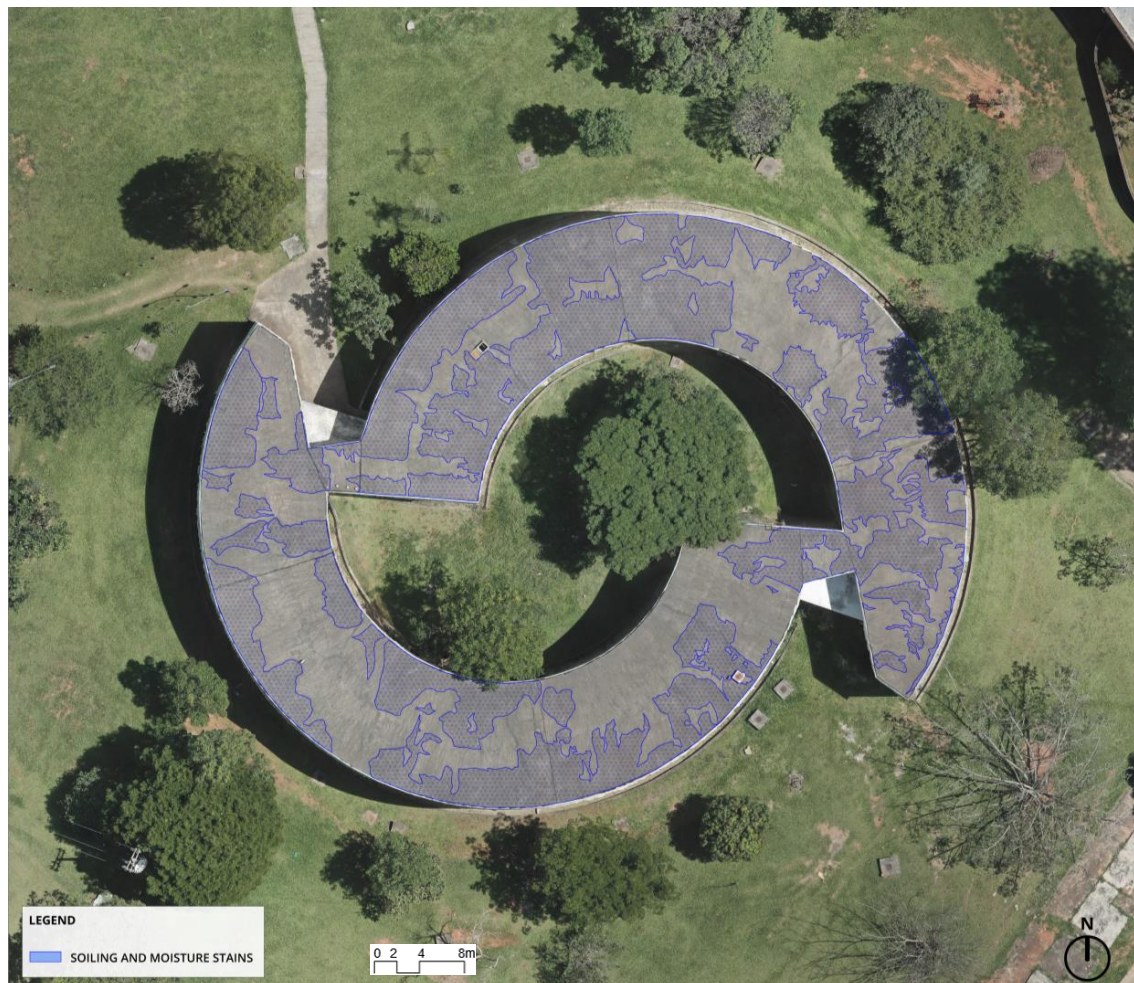
Figure 5 shows the damage map constructed from an orthoimage captured with the drone at the end of a rainy period. It identifies the main stains affecting more than 50% of the roofing system area, with emphasis on soiling stains from particle deposition and differential washing, as well as moisture stains resulting from the accumulation of rainwater due to problems in directing the flow. The lighter-colored stains, from the center to the edges, across the entire extent of the roof, are those caused by the carrying of dirt, while the darker-colored stains, which are deposited along the edges of the curves that shape the building, signal points of moisture retention.

The area of the building exhibiting moisture stains and dirt covers approximately 780 m², which represents 48.75% of the total area. It can be observed that both sections of the building, the north and south, display similar levels of staining. However, there is a slightly higher incidence of this type of pathological manifestation on the northernmost roof, attributed to differences in roof slope caused by execution errors.

Figure 5. Damage map of the roof of the Sustainable Development Center: highlighting soiling and moisture stains. Source: the authors.

The extent, shape, and dimensions of the soiling and moisture stains recognized in the damage map indicate that, in certain sections, the runoff and drainage of rainwater

occur as anticipated in the project, as it is possible to identify, through the uniform stains, the path taken from the ridge towards the drip edges at the ends of the flat roof. Moreover, there is no puddling of water on the roof, since rainwater is not directed to gutters, but to edges that project it into freefall to the ground.

On the other hand, the configurations of the moisture stains, which have dark coloring and irregular shapes and are concentrated along the edges of the blocks, point to deficiencies in runoff and moisture retention which, if not corrected, can lead to water percolation and infiltration problems. Observing the configuration of the stains, it is noted that the runoff of rainwater begins to follow the semicircular shape of the building, moving according to the irregularities of the surface.

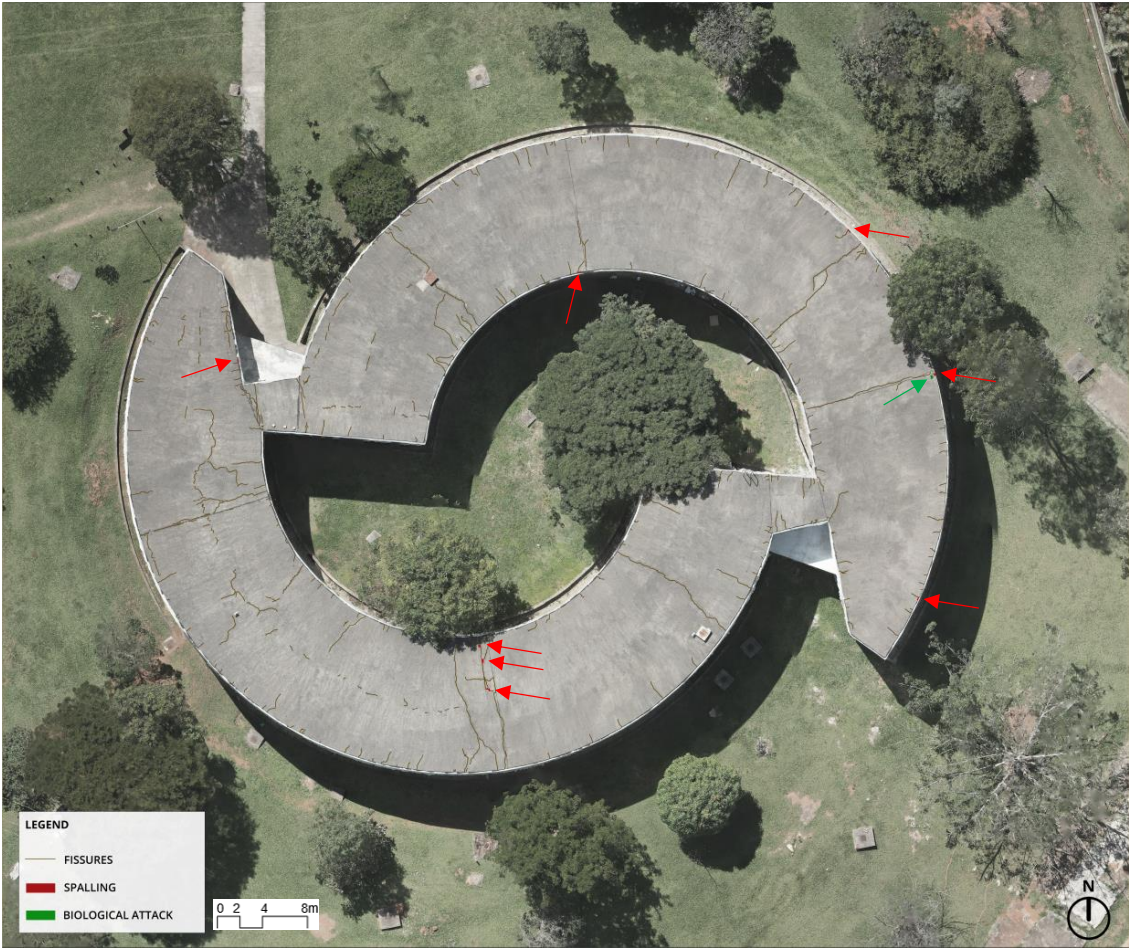
The damage map in Figure 6, developed from an orthoimage captured with the drone at the beginning of the dry period, shows anomalies identified as cracks, spallings, and stains from biological attacks.

Among the cracks, transversal cracks from one edge to the other, longitudinal cracks next to the water divider (ridge), and cracks distributed along the edges of the mechanical protection, in both the inner and outer curves, stand out. Their width varies between 1 mm and 5 mm, and their depth oscillated between 1 mm and the entire thickness of the protective mortar layer.

Spalling generally occurs alongside cracks and along the edges of the flat roof, in sections where hygrothermal variation causes tensions that break the mechanical protection layer. During the inspection of the waterproofing system, the process of detecting the

Biological attack typically occurs in proximity to existing trees and is primarily caused by the decomposition of organic matter, such as leaves and small branches, which accumulate on the surface of the mechanical protection. This process is exacerbated by the presence of a moist and shaded environment, which provides ideal conditions for the proliferation of microorganisms or even the growth of vegetation. The roots of this vegetation can penetrate the mechanical protection layer, causing cracks and spalling, which further contribute to the degradation of the protective layer.

Figure 6. Damage map of the roof of the Sustainable Development Center: highlighting cracks, spallings, and stains from biological attacks. Source: the authors.

The damage map also indicates that the transversal cracks at the ends of the mechanical protection follow a certain frequency and rhythm, since the spacing, length, and thickness are uniform. Being located between the straight segments that form the curvature of the building, always at the change of direction of the panels, their occurrence is related not only to the effects of hygrothermal variation but also to the different movements due to geometry, which tend to open or expand in a non-linear way in structures with a circular/semicircular shape. Another possible cause is the differential expansion between the mechanical protection mortar and the galvanized drip sheet along the perimeter of the roof, whose tensions can lead to spalling.

In instances where transversal cracks extend from one edge to the other, strategically situated roughly at the midpoint of the span delineated by the building's structural expansion joints, their specific arrangement, thickness, and occurrence provide insights into the operational behavior of the structure. This phenomenon appears to be an effort to effectively divide the roof into smaller, more manageable panels. The purpose behind this segmentation is likely aimed at mitigating stress and enhancing the overall stability and integrity of the roofing system, thereby accommodating natural movements and adjustments within the building's framework.

The mechanical protection layer contains only four expansion joints, which align with the building's structural expansion joints. This configuration leads to tension from hygrothermal variations, causing shifts in the mechanical protection layer and damage to the waterproofing membrane. The presence of moisture stains on the gypsum ceiling below indicates where the membrane has broken in some sections.

Other cracks are also identified in the sections corresponding to the water dividers and close to the structural expansion joints of the building. The presence of dark stains signals water percolation through the cracks, making the roofing system susceptible to moisture and the deleterious action of fluids. This finding reinforces the need for proper sizing of expansion joints, both in the slab and in the mechanical protection layer, to combine the tensions from structural movement due to hygrothermal variation, thus reducing the risk of cracking.

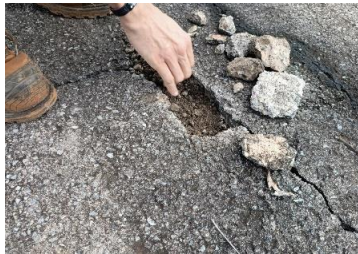
Spallings	The stresses arising from structural expansion due to hygrothermal variation reach such intensity in some sections that they can cause displacement of the mechanical protection layer and rupture of the waterproofing membrane, as indicated by the infiltration and moisture stains found in the gypsum ceiling (roof) of the upper floor.

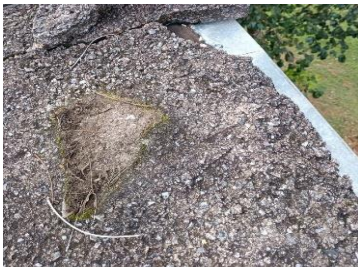
Biological attack	Due to its location in a region of intense tree coverage, some leaves that settle on the mechanical protection layer in shaded areas and with localized moisture retention end up promoting biological colonization and the development of molds, mosses, and vegetation.
