**ESCOAMENTO SUPERFICIAL E PERDA DE SOLO EM
ÁREAS DEGRADADAS, RESTAURADAS E NATURAIS
DOS CERRADOS, USANDO PARCELAS ABERTAS**

DISSERTAÇÃO DE MESTRADO EM CIÊNCIAS FLORESTAIS

BRASÍLIA/DF: DEZEMBRO/2025

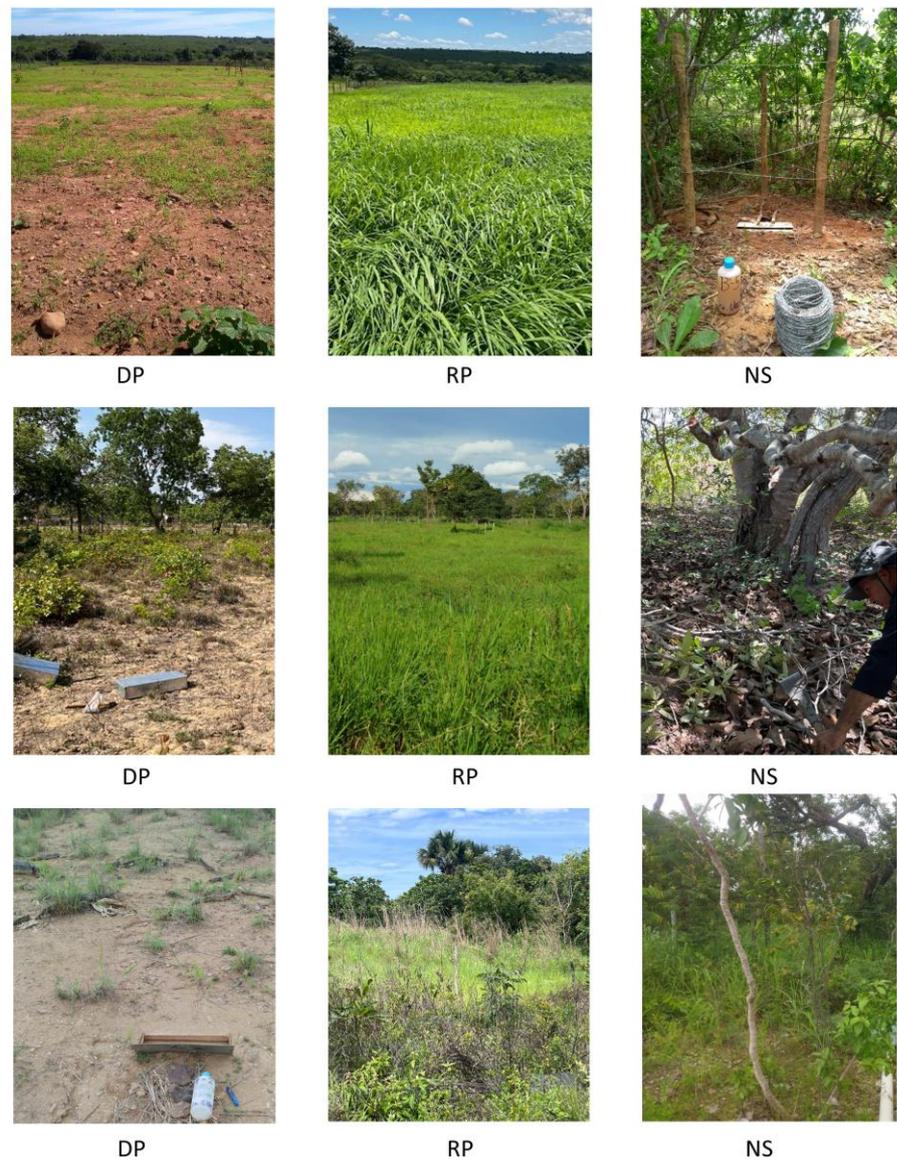
Figure 2 shows the degraded pasture (DP), restored pasture (RP), and natural savannah (NS) condition in all 3 farms, during the second year of the study, indicating the significant improvement in soil cover between DP and RP.

Figure 2- Degraded pasture (DP), restored pasture (RP), and natural savannah (NS) condition in all 3 farms

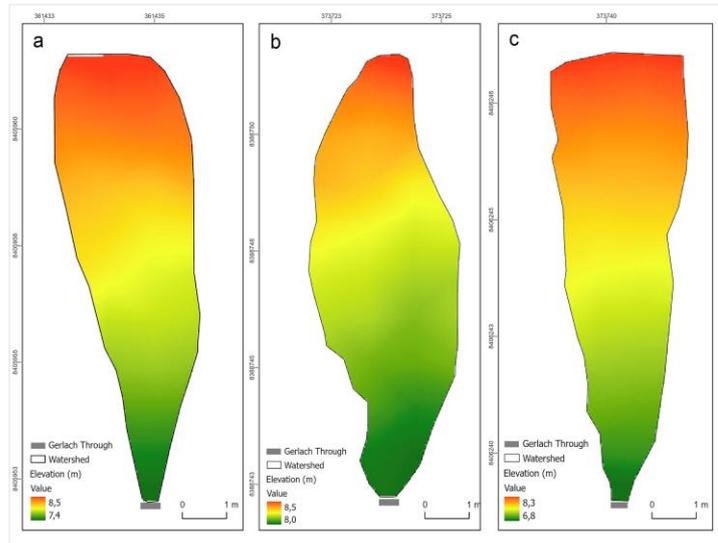
In each treatment plot (natural savannah, degraded & restored pasture) within each block/farm, two Gerlach collectors (N=2 replicates) were installed to collect the upstream runoff and sediment, since the plot conditions were small (< 1 ha) and homogeneous. One collector was set in the left upslope portion of the plot and the other in the right downslope portion, to guarantee site representativeness. Since Gerlach collectors seldom consider the contributing drainage area, a detailed topographic survey of the immediate upstream area of each collector was carried, to obtain the collectors' drainage areas and slope characteristics (Figure 3). The runoff plots' contributing areas are presented in Table 3. The mean plot length

was 8.5m, with a standard deviation of 0.15 m.

Figure 3 - Runoff plots' contributing areas

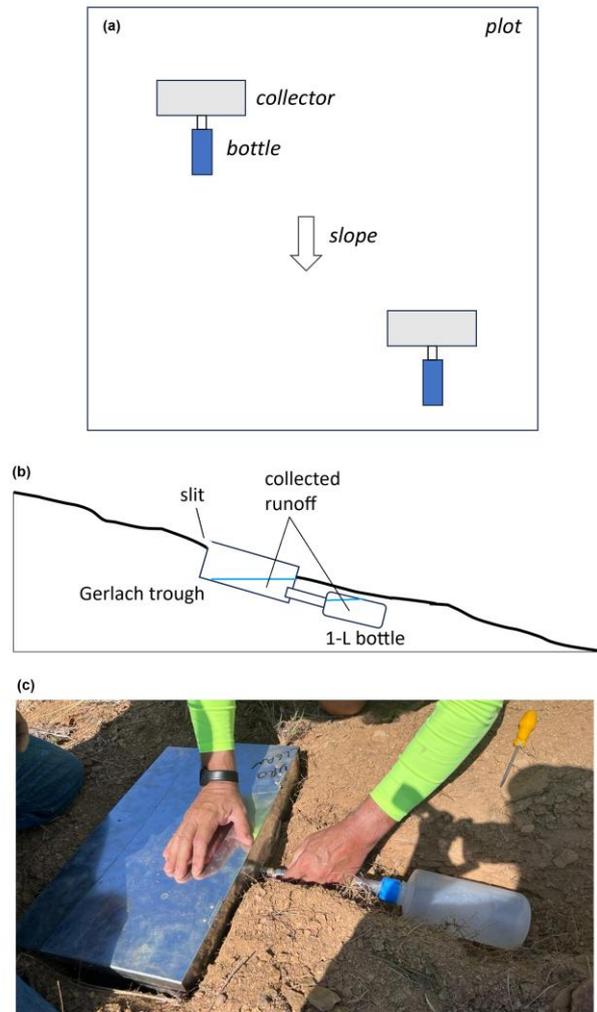
In the lower end of each plot, a metallic Gerlach collector (Gerlach, 1967) was installed flush with the soil surface, so that runoff and sediment were adequately collected. In the lower portion of the collector, a 1-L *Nalgene*® bottle was attached with a plastic hose to an orifice in the collector's lower end (Figure 4). In each experimental site, a rain gage was installed, and readings of precipitation volume were taken whenever the runoff & sediment samples were collected.

Figure 4 - Gerlach trough

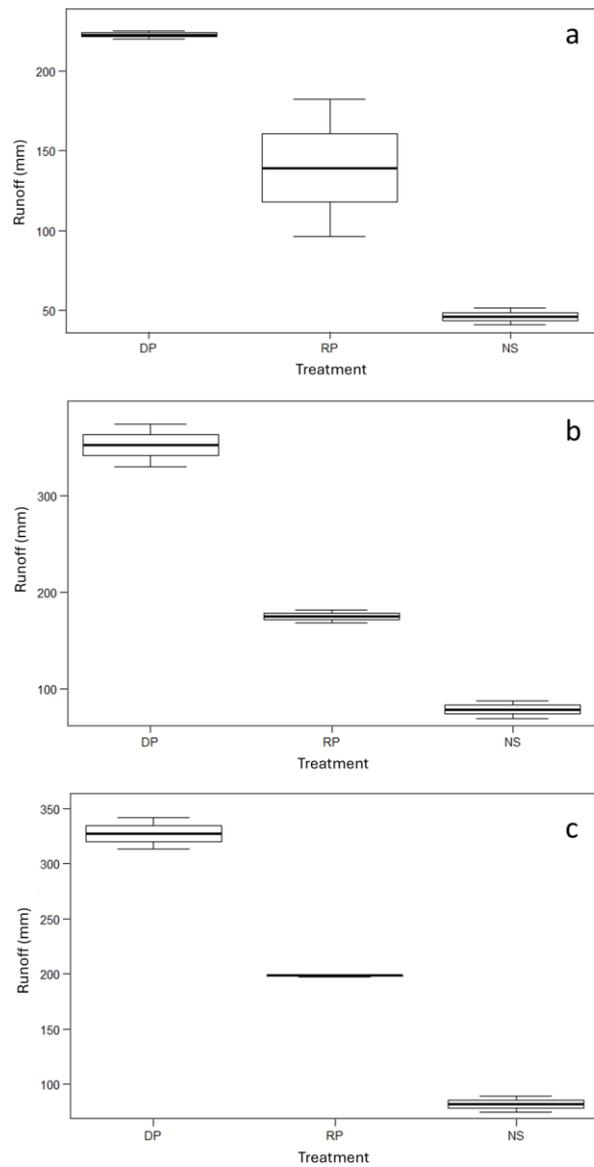
Figure 5 shows the box plots of the mean annual runoff volume assessed in the different treatment plots (means of N= 2 replicates, 2 years) of the Funil, Progresso, and Tarimba farms, and Table 6 shows the results of the Tukey multiple-range test.

Figure 5 - Mean annual runoff volume collected

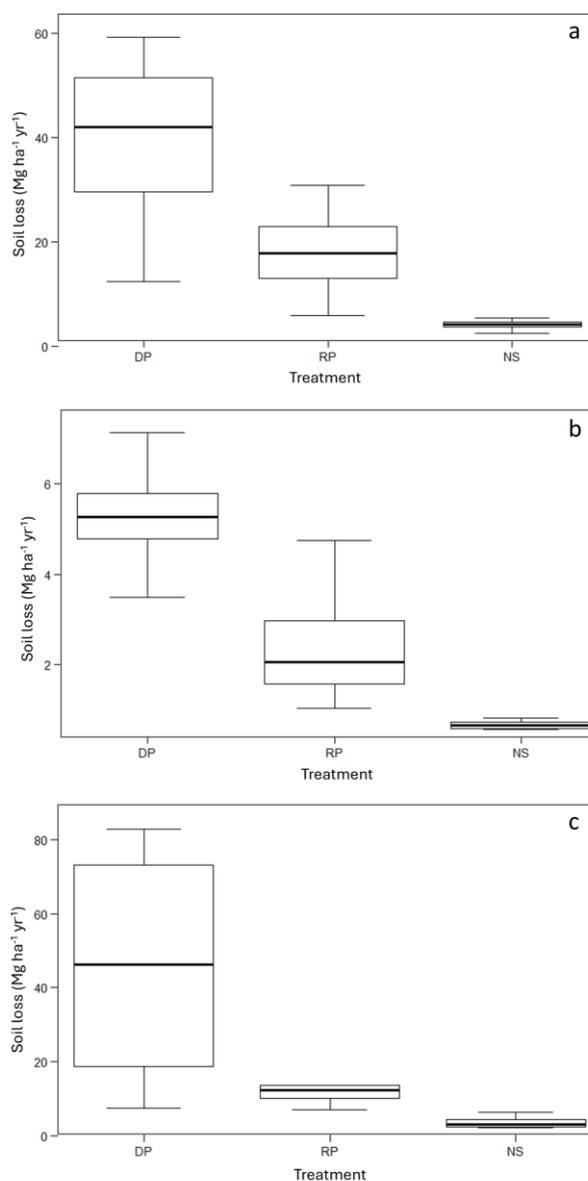
Figure 6 shows the box plots of soil loss collected in the different treatment plots (means of N= 2 replicates, 2 years) for the Funil, Progresso, and Tarimba sites. Since the correction factor (F_C) of equation 4 was 0.95, it was taken as unity. Table 7 shows the results of the Tukey multiple-range test form mean annual soil loss in the three experimental sites.

Figure 6 - Box plots of soil loss collected in the different treatment plots

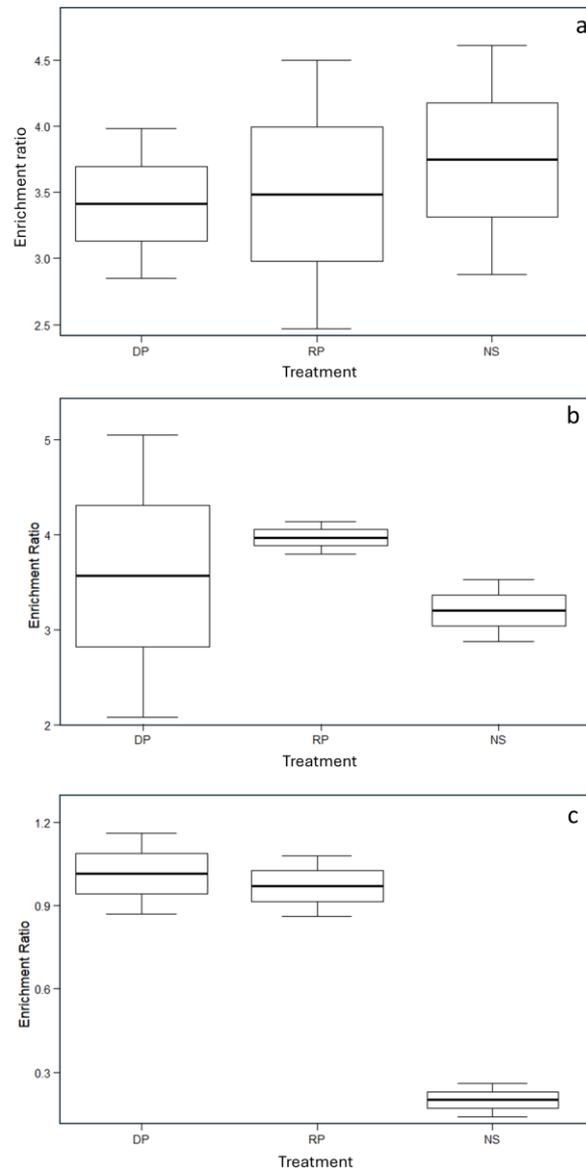
The sediment enrichment ratios of the three treatments in the Funil, Progresso, and Tarimba farms for the two hydrologic years (N=4, means of 2 years) are presented in Figure 7. Table 8 shows the results of the Tukey multiple-range test for the sediment enrichment ratio.

Figure 7 - Sediment enrichment ratios of the three treatments in the Funil, Progresso, and Tarimba farms for three two hydrologic Years

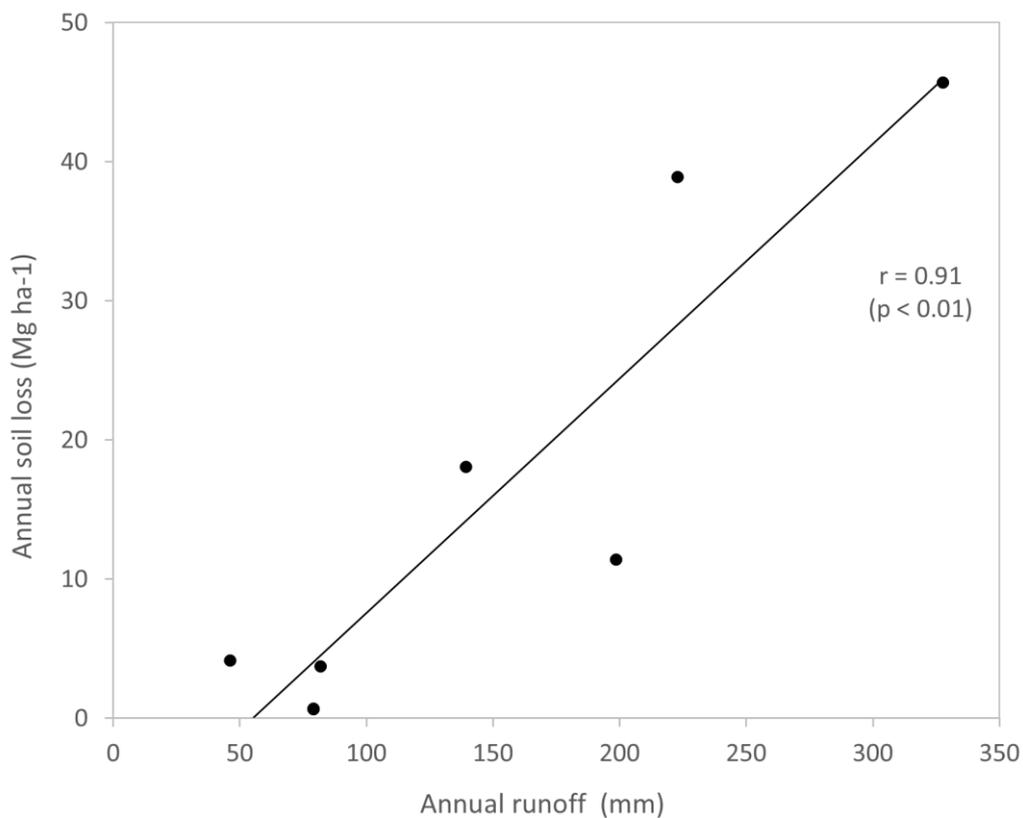
Figure 8 presents the relationship between mean annual runoff and annual soil loss of the experimental plots, in the two hydrologic years, and Figure 9 shows the experimental data (solid points) plotted against the scatter-plot of other 50 runoff and soil loss data of non-karst areas of the Brazilian savanna, compiled by Fonseca et al. (2021) (hollow points). Triangles in the Figure represent plots without permanent cover (NP) and circles represent plots with permanent (P) cover.

Figure 8- relationship between mean annual runoff and annual soil loss of the experimental plots, in the two hydrologic years

The Spearman-r between the plots' runoff and soil loss was 0.91 ($p < 0.01$), indicating a high correlation between the two variables. The fitted equation of the data of Figure 9, encompassing both karst and non-karst areas of the Brazilian savannah, was $SL = 0.0059 Q^{1.37}$ ($p < 0.01$).

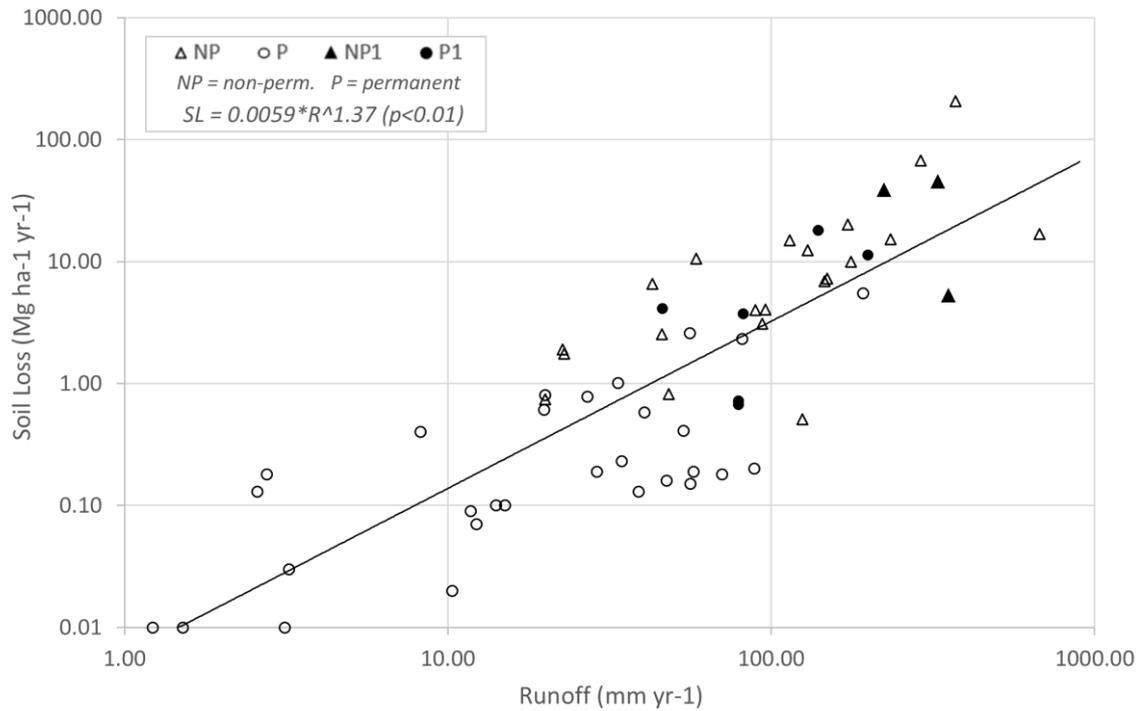
Figure 9 - fitted equation of the data

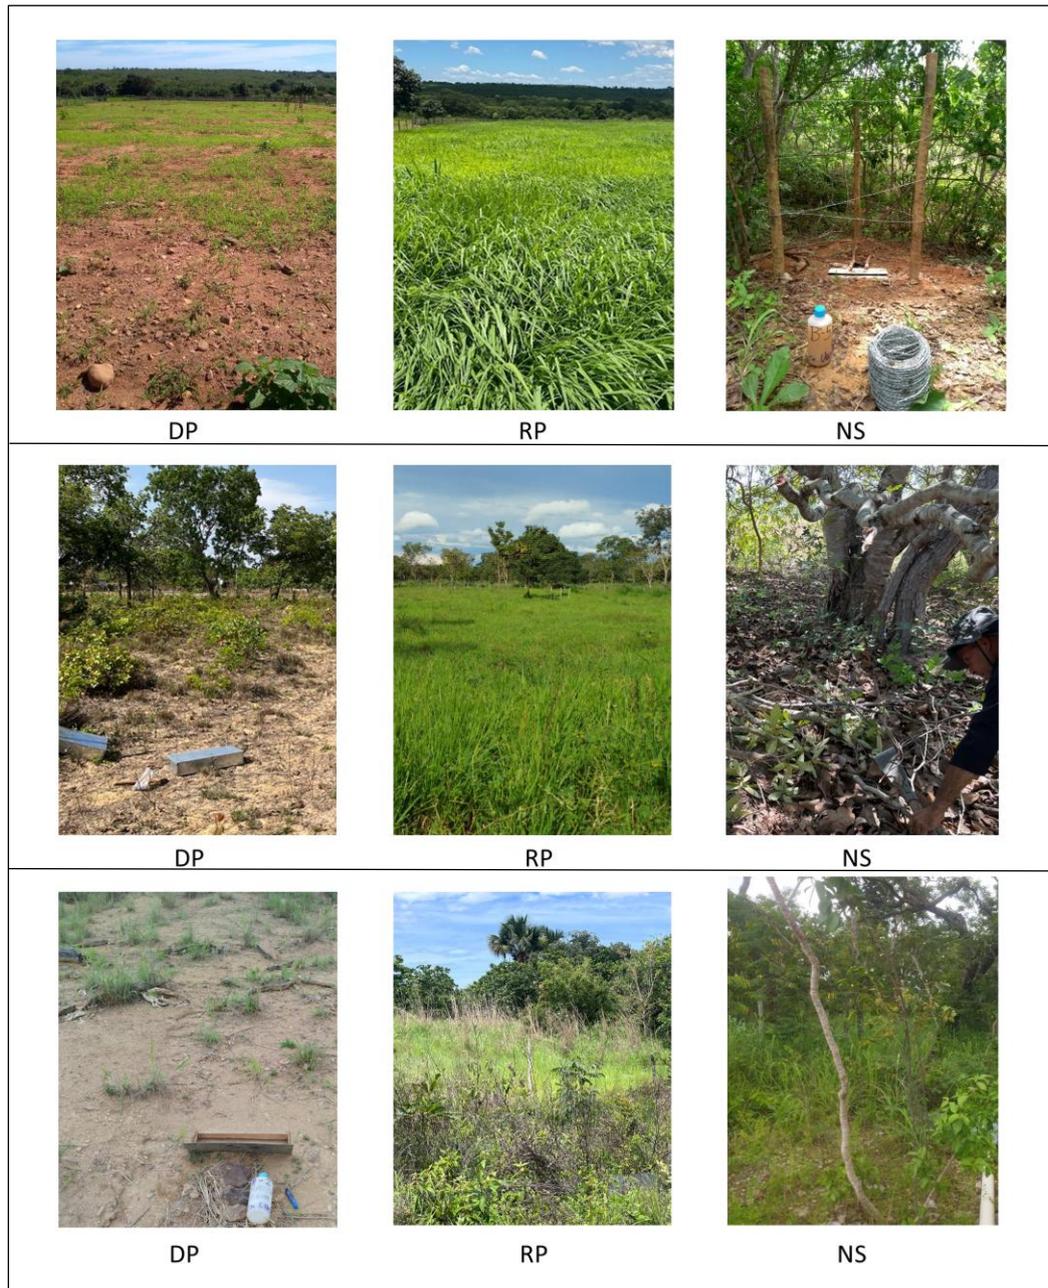
Within each block (farm), the NS, DP and RP treatments were installed in the same soil type and had similar slope gradients (Table 1), allowing the plots to be taken as independent treatments (Figure 2). All plots were fenced to prevent cattle intrusion.

Figure 2. Soil covers under different treatments in the three experimental sites. From top to bottom: Funil farm, Progresso farm, Tarimba farm. DP = degraded pasture; RP = restored pasture; NS = natural savannah.

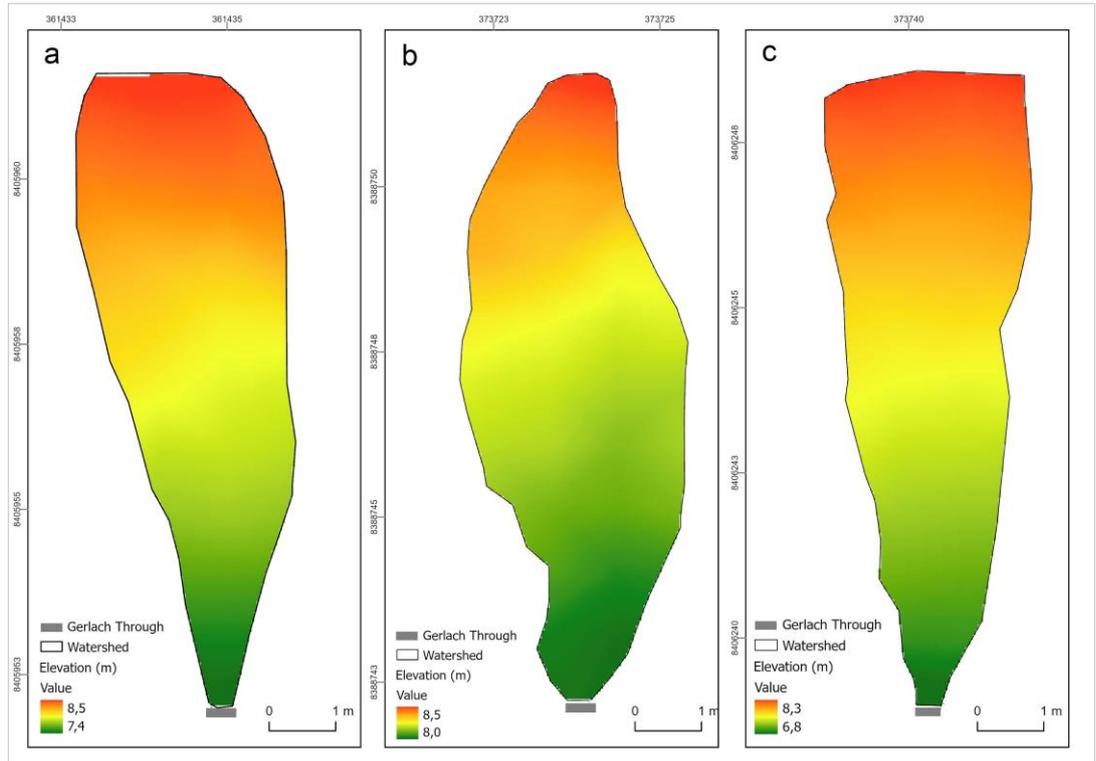
Within each treatment plot, two Gerlach troughs were installed, one on the upper slope area and the other on the lower slope, to collect the upstream runoff and sediment. To avoid the interference of vegetative cover, a planialtimetric survey of the plot areas was carried with a RTK surveying equipment, using pins installed in a 0.5 x 0.5 mesh, to determine the exact plot drainage area and slope grade (Figure 3). The drainage areas of the runoff plots of the three farms are presented in Table 3.

Figure 3: Examples of drainage areas and elevation of selected Gerlach plots: (a) Funil farm; (b) Progresso farm; and (c) Tarimba farm, showing the Gerlach troughs in the plot outlets.

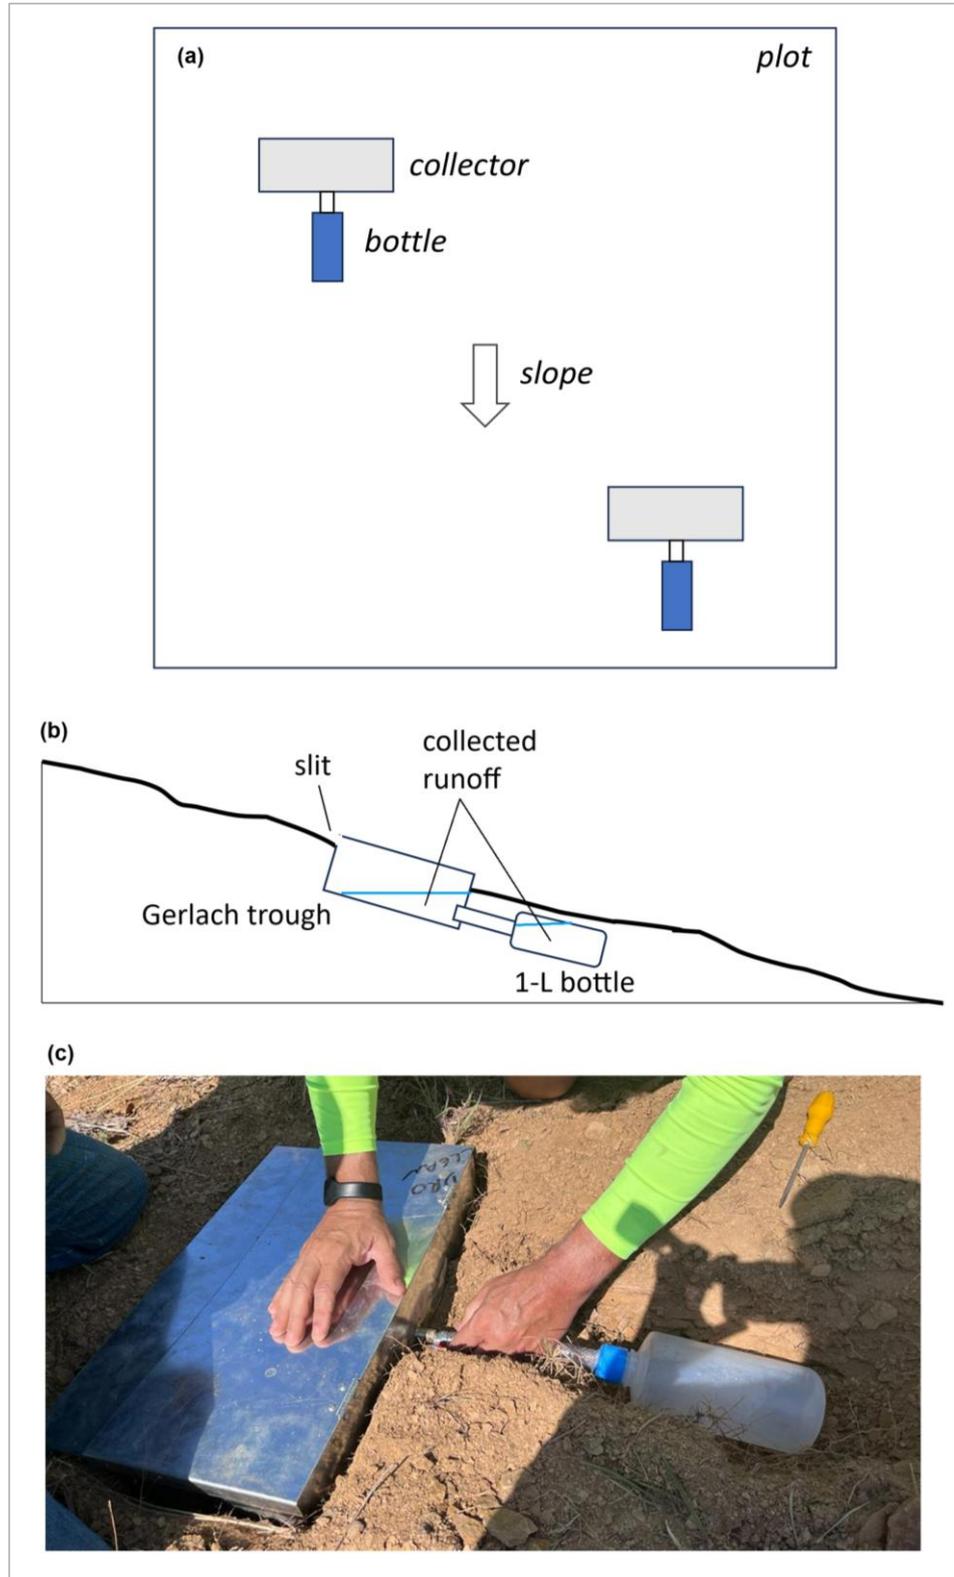
At the lower end of each runoff plot, a metallic Gerlach trough [24] was installed flush with the soil surface to ensure proper collection of runoff and sediment. A 1-L Nalgene® bottle was connected to the trough's downstream outlet by a plastic hose to collect the runoff samples (Figure 4).

Figure 4: Layout and arrangement of the Gerlach troughs: a) Top view; b) Slope cross-section; c) Trough and bottle detail.

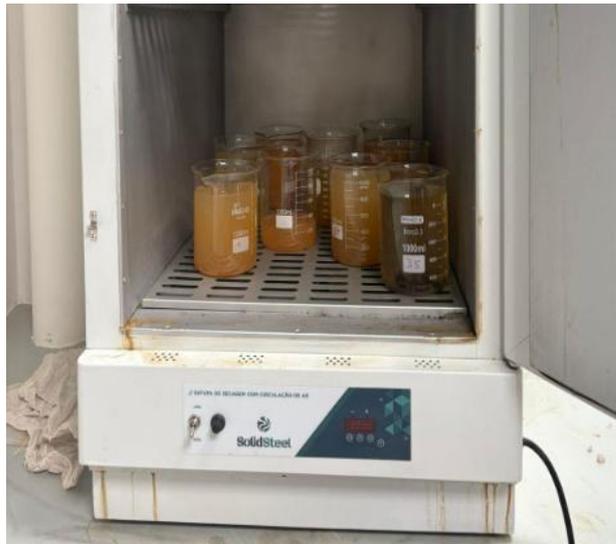
The 1-L runoff bottles were collected whenever rainfall exceeded 10 mm, since this is the threshold for runoff generation [31], which was confirmed empirically in a previous study in a nearby experiment [3]. In the laboratory, the contents of the Gerlach bottles were transferred to beakers, decanted with alum, oven-dried at 100° C for 48h (Figure 5), and weighed to determine runoff volume and sediment concentration

Figure 5. Oven-drying of runoff samples in the laboratory.

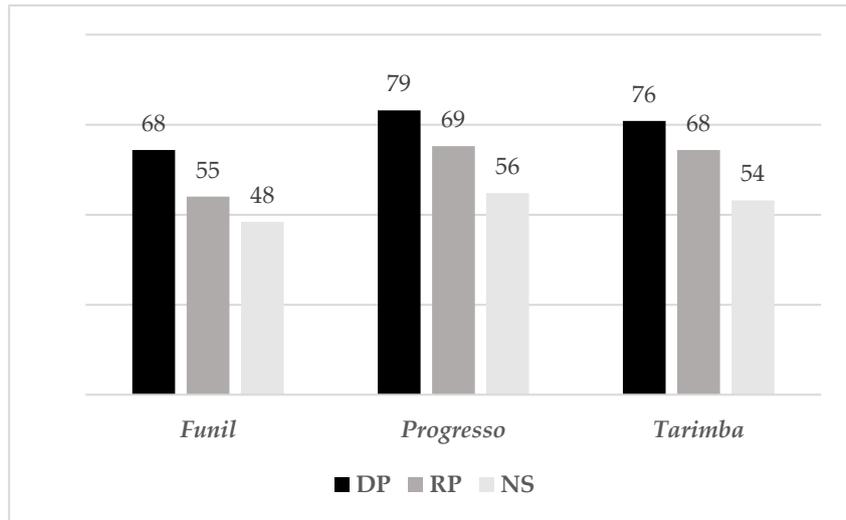
The calibrated runoff curve-numbers (CN) of eqs. (2) and (3) of the three sites are presented in Figure 6.

Figure 6. Calibrated runoff curve-numbers (CN) of the experimental sites and plots. DP = degraded pasture; RP = restored pasture; NS = natural savannah.

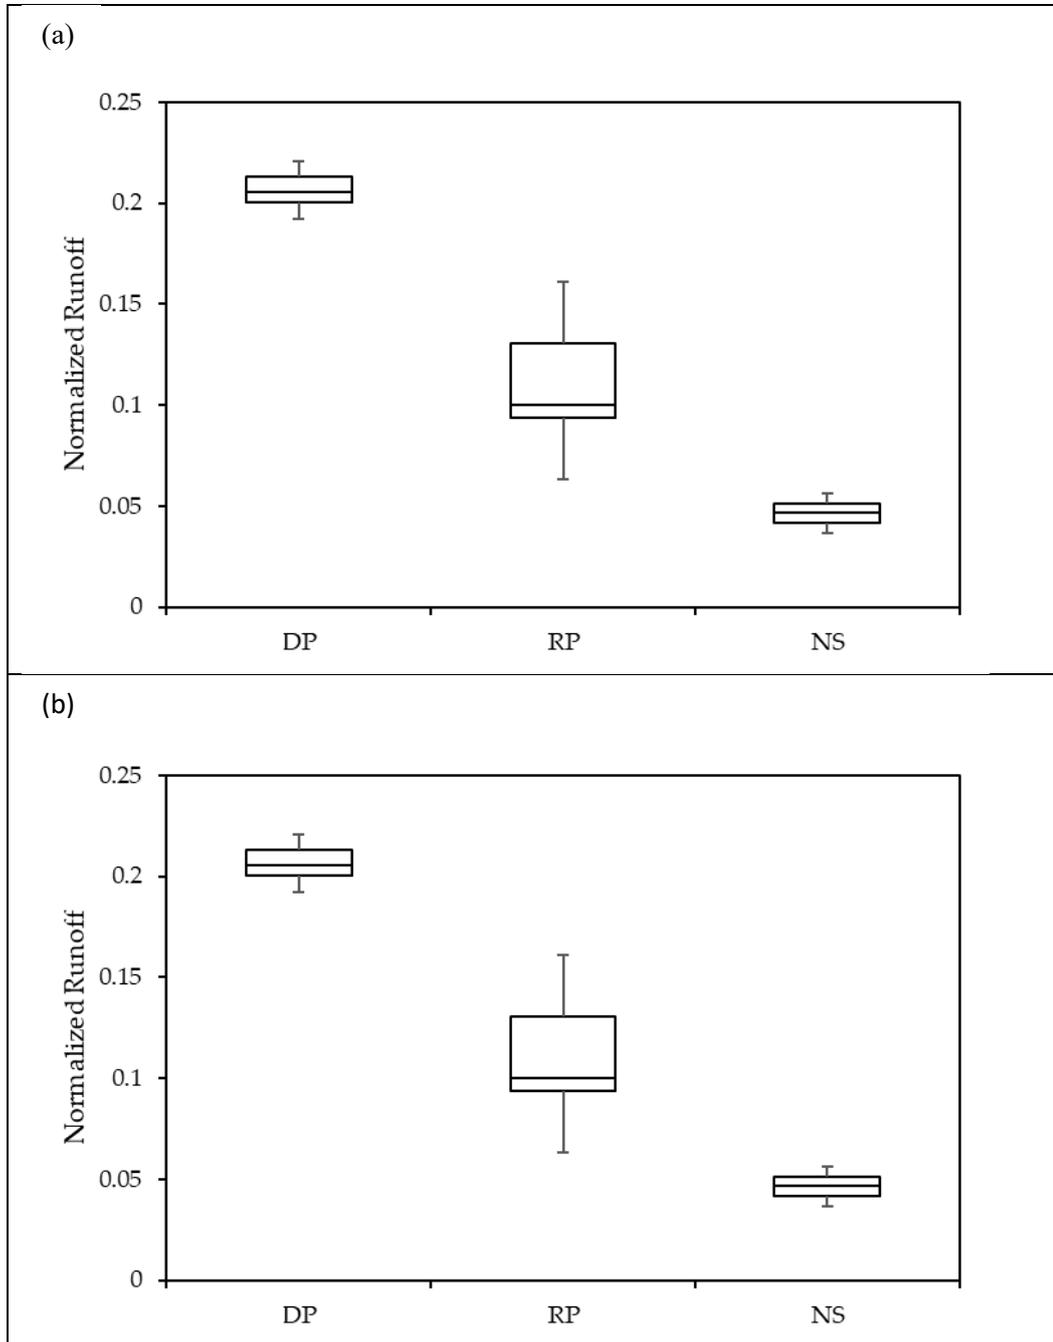
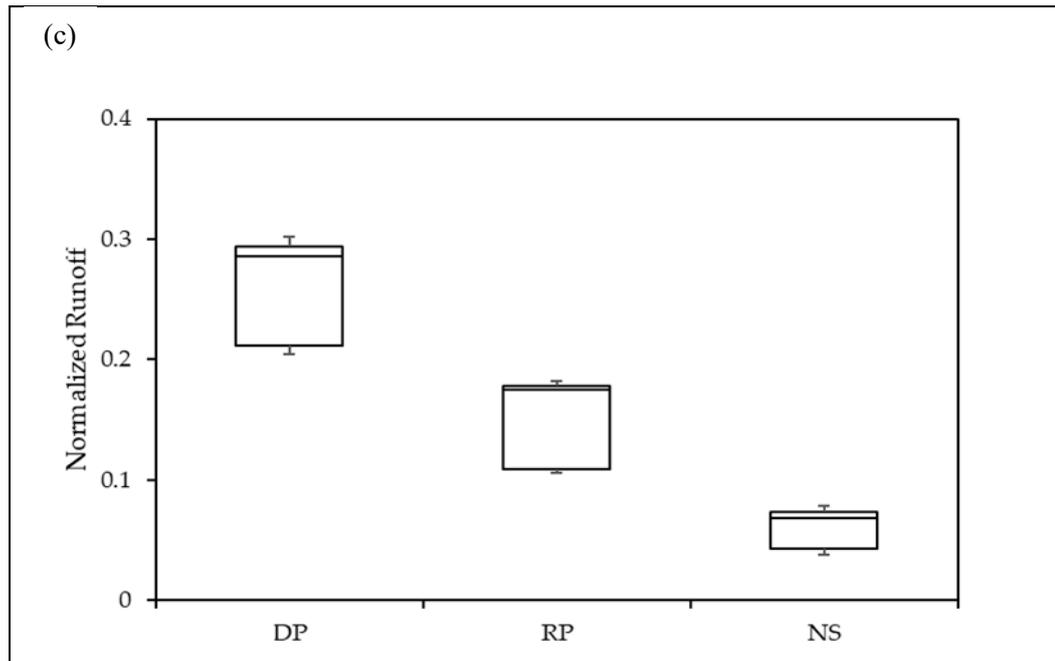
The box-plots of normalized mean annual runoff are presented in Figure 7. In all cases, NS exhibited the lowest values with minimal variability, while DP consistently showed the highest runoff. RP, in turn, occupied an intermediate position between the other treatments.

Figure 7: Box-plots of normalized runoff for the Funil farm (a), Progresso farm (b) and Tarimba farm (c). DP = degraded pasture; RP = restored pasture; NS = natural savannah.

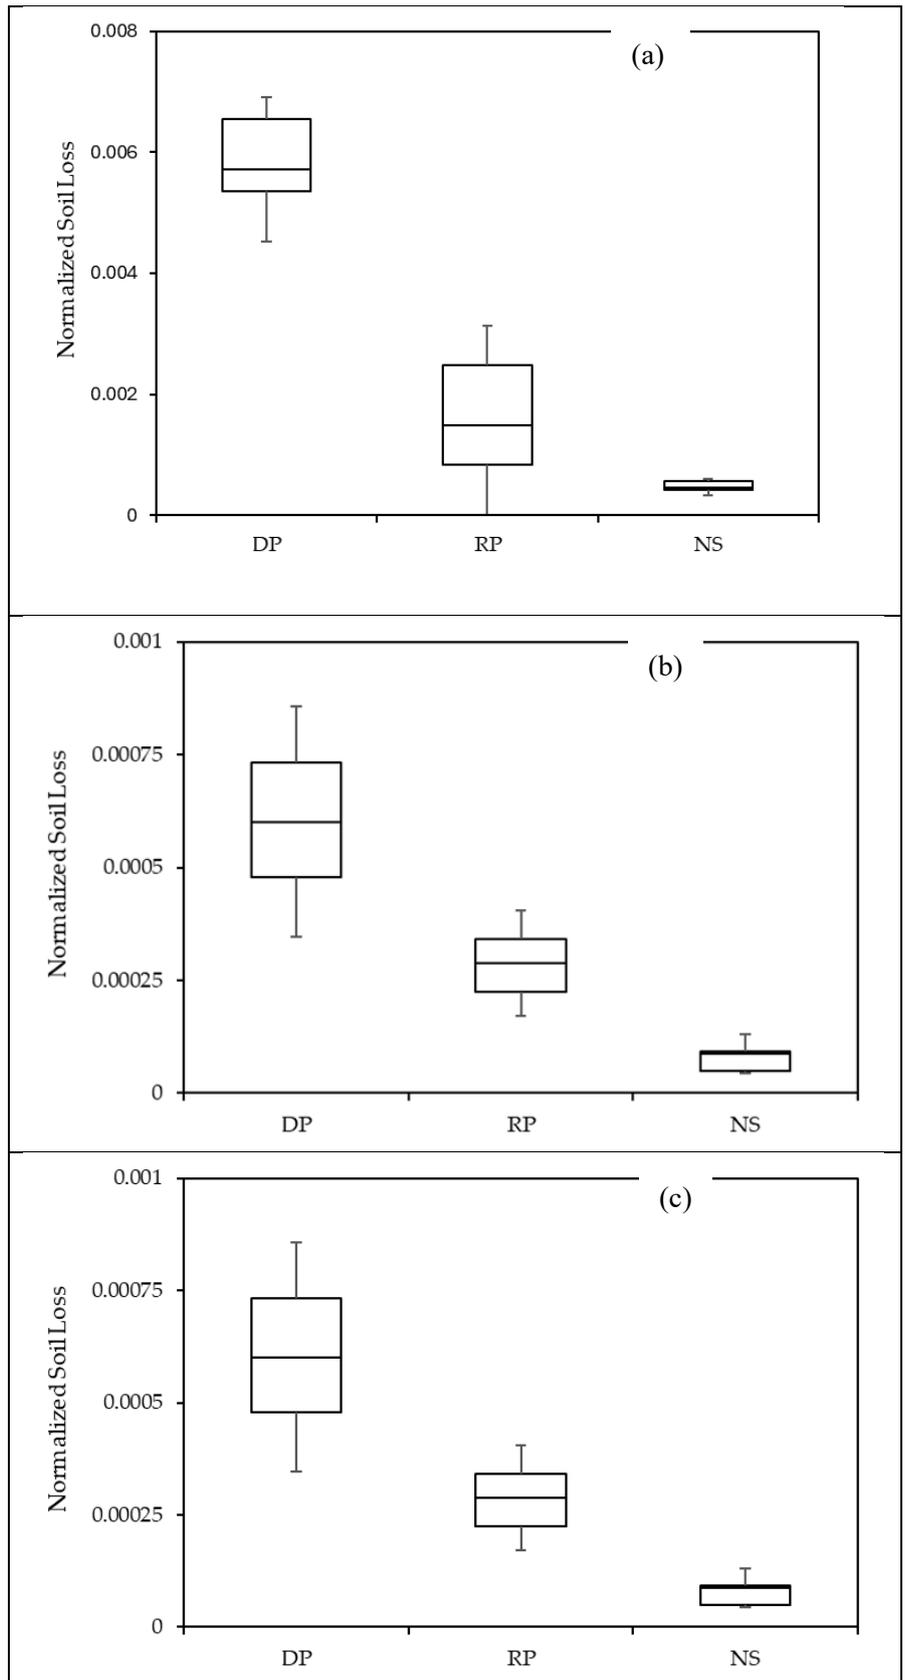
The box-plots of normalized soil loss are presented in Figure 8 for the three sites. In all cases, NS exhibited the lowest values with minimal variability, while DP consistently showed the highest soil loss. RP, on the other hand, occupied an intermediate position

Figure 8: Distribution of Normalized soil for Funil farm (a), Progresso farm (b) and Tarimba farm (c). DP = degraded pasture; RP = restored pasture; NS = natural savannah.

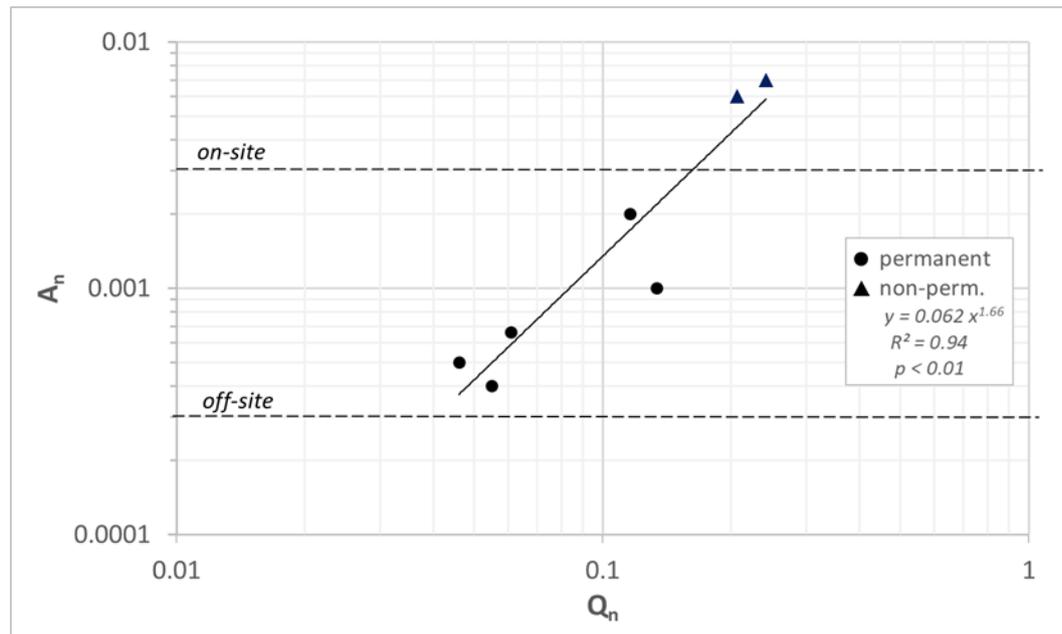
The relationship between normalized annual runoff and annual soil loss is presented in Figure 9. In this Figure, a good fit ($R^2 = 0.94$, $p < 0.01$) was obtained for a power function, similar to that of non-karst landscapes of the Brazilian savannah [18].

Additionally, the soil loss of all permanently covered plots (NS & RP) fell below the on-site soil loss tolerance, as opposed to the degraded pasture plots (non-covered plots).

Figure 9. Relationship between normalized runoff (Q_n) and soil loss (SL_n) for permanent and nonpermanent treatment covers, showing the on- and off-site tolerance thresholds (dotted lines).
