INOJOSA, Leonardo da Silveira Pirillo et al. Numerical safety and performance analysis of a multipurpose building's structure : case study. **Concilium**, [S. l.], v. 23, n. 19, p. 87–99, 2023. DOI: <https://doi.org/10.53660/CLM-2070-23P19>. Disponível em: <https://clium.org/index.php/edicoes/article/view/2070>. Acesso em: 31 jan. 2024.

## Numerical Safety and Performance Analysis of a Multipurpose Building's Structure – Case Study

### Análise Numérica de Segurança e Desempenho da Estrutura de Edifício Multiuso – Estudo de Caso

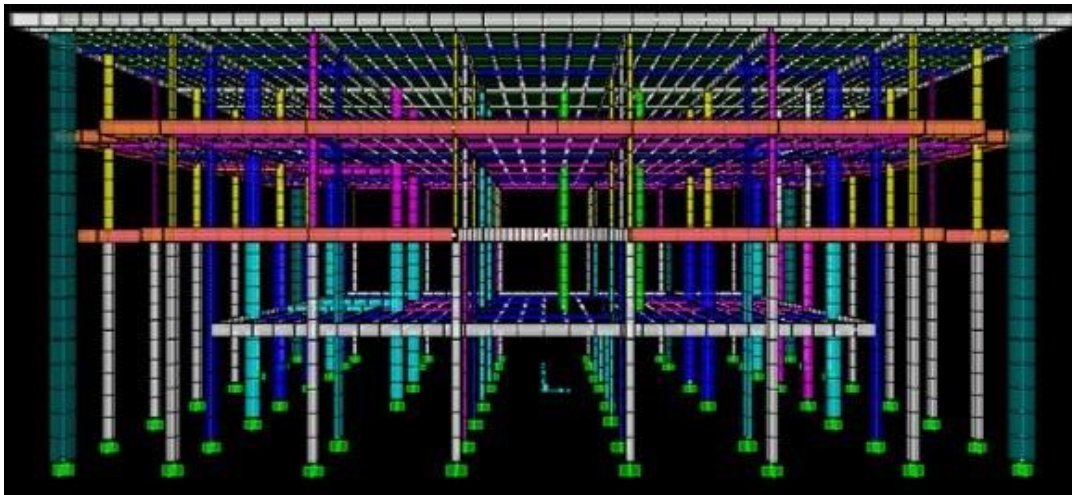
**Figure 3** – Topology – Perspective of the structural model – SAP-2000 Program.

The concrete structure of the building is made up of spatial gantry elements and four-node plates, as seen in Figure 3. Floor plans for the ground floor, overstore, first and second floors, and roof can be seen in Figure 4. The analytical model in the SAP 2000 program is shown from a perspective in Figure 5.

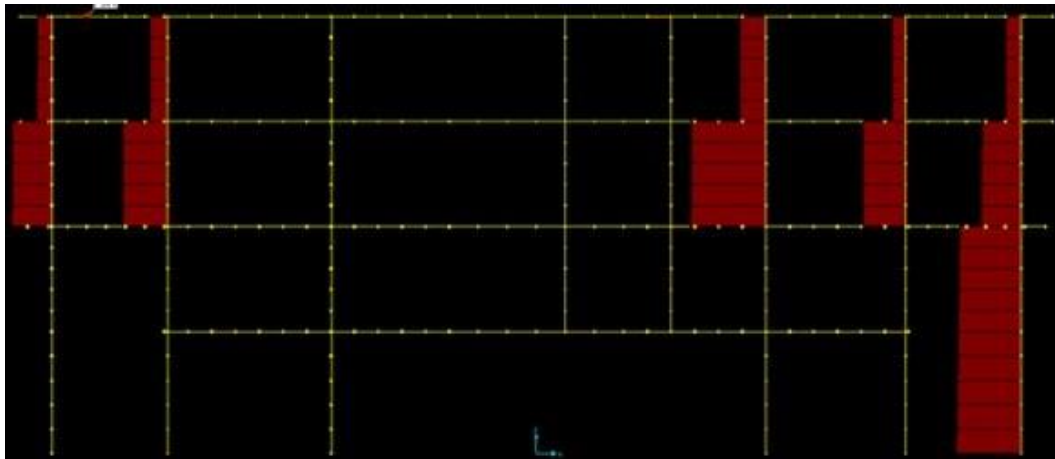
**Figure 6** – Nominal Axial Efforts in the Internal Columns.

Extensive analysis was conducted to verify the utmost safety and stability of the structure. This involved examination of the slabs, beams, and columns to assess their capacity to withstand external forces, as well as to confirm their maximum horizontal and vertical displacements. A visual representation of the Nominal Axial efforts in the structure's columns is shown in Fig. 6 which displays a schematic cut.

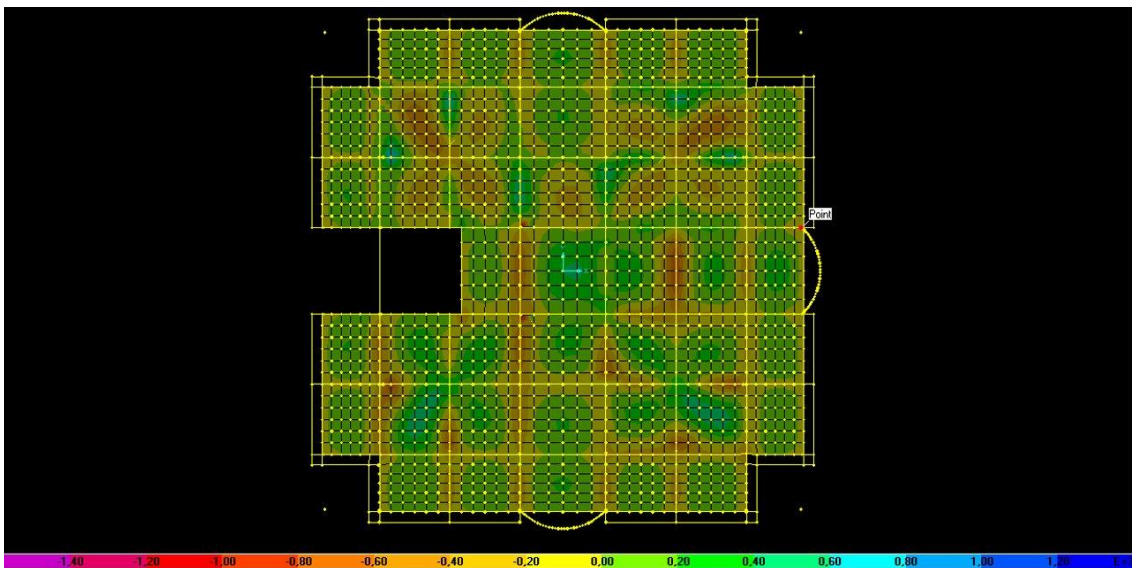
**Figure 7** – Bending Moment M11 – X (Overstore)

The graphs below, Fig. 7 and Fig. 8, show moments M11 in the X direction and M22 in the Y direction of the overlay floor. These were obtained from the analysis made in 2005 using the SAP 2000 program.
